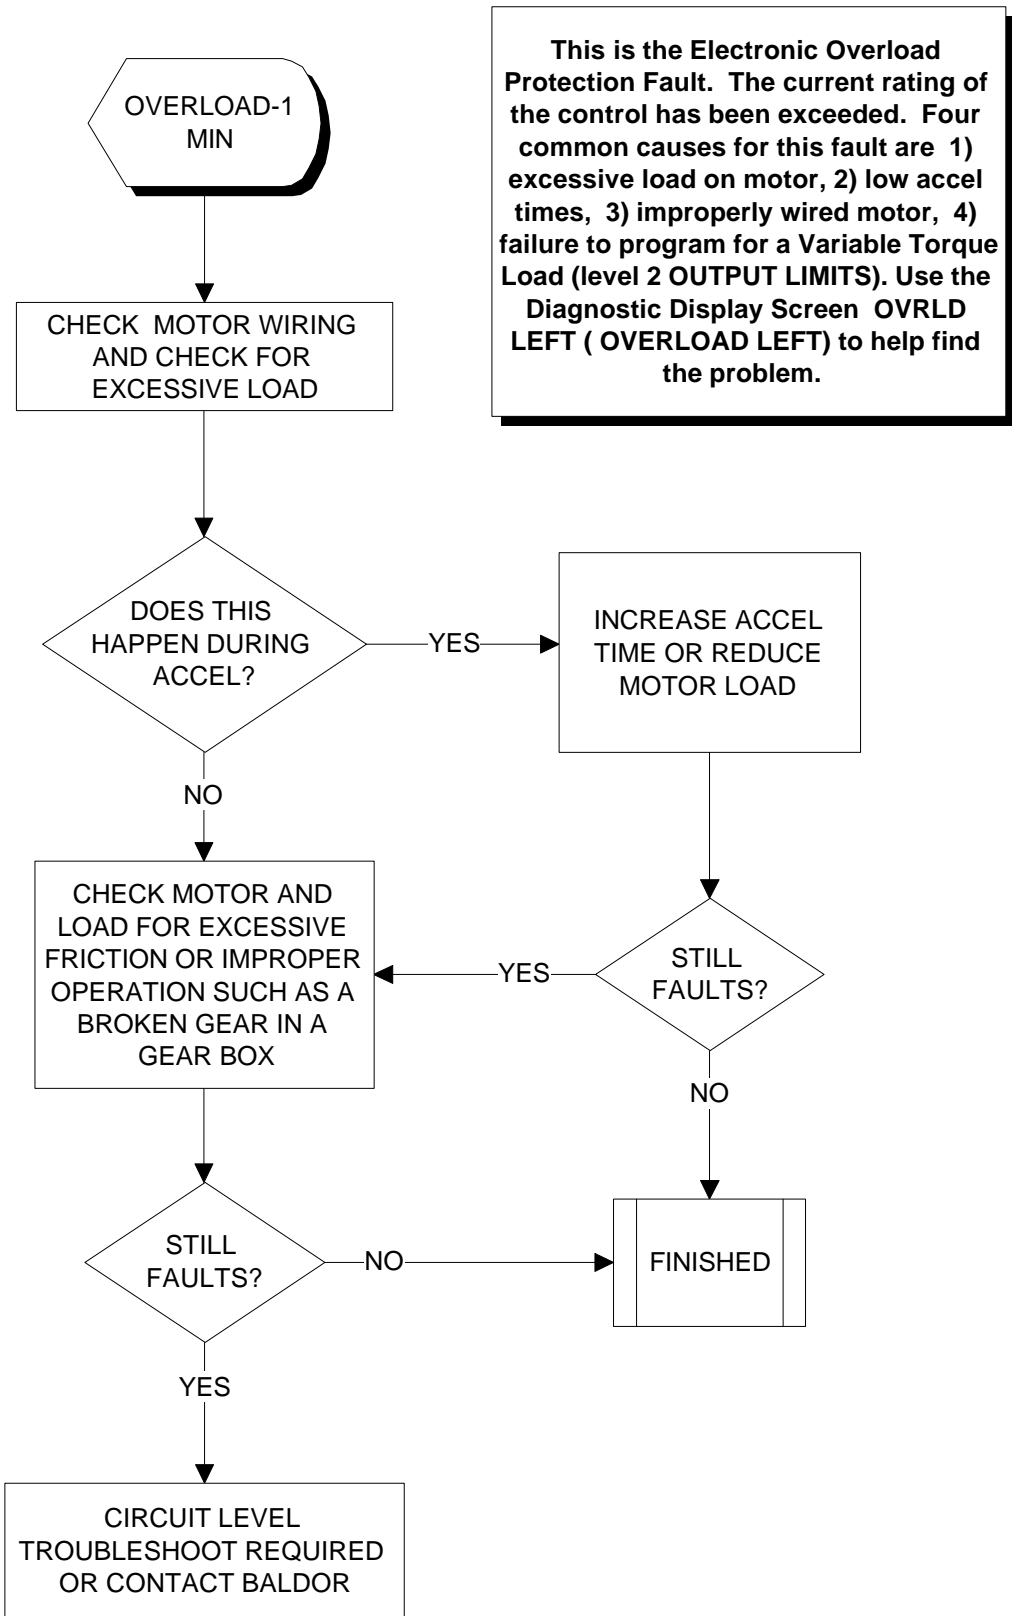
This is the Electronic Overload Protection Fault. The current rating of the control has been exceeded. Four common causes for this fault are 1) excessive load on motor, 2) low accel times, 3) improperly wired motor, 4) failure to program for a Variable Torque Load (level 2 OUTPUT LIMITS). Use the Diagnostic Display Screen OVRLD LEFT (OVERLOAD LEFT) to help find the problem.

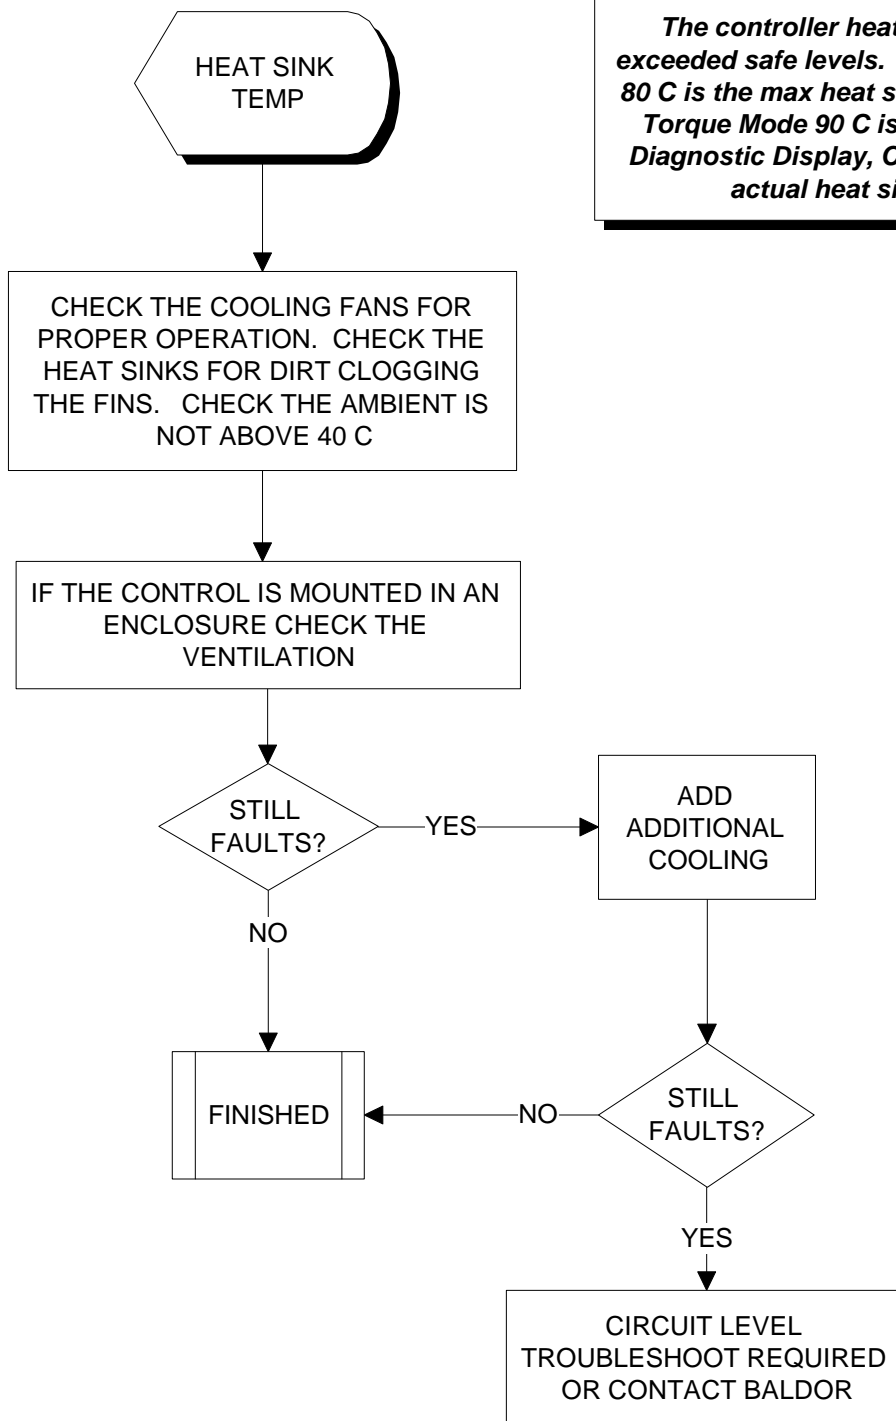
The controller heat sink temperature has exceeded safe levels. In Constant Torque Mode 80 C is the max heat sink temp., and in Variable Torque Mode 90 C is the maximum. Use the Diagnostic Display, CONTROL TMP to see the actual heat sink temperature.

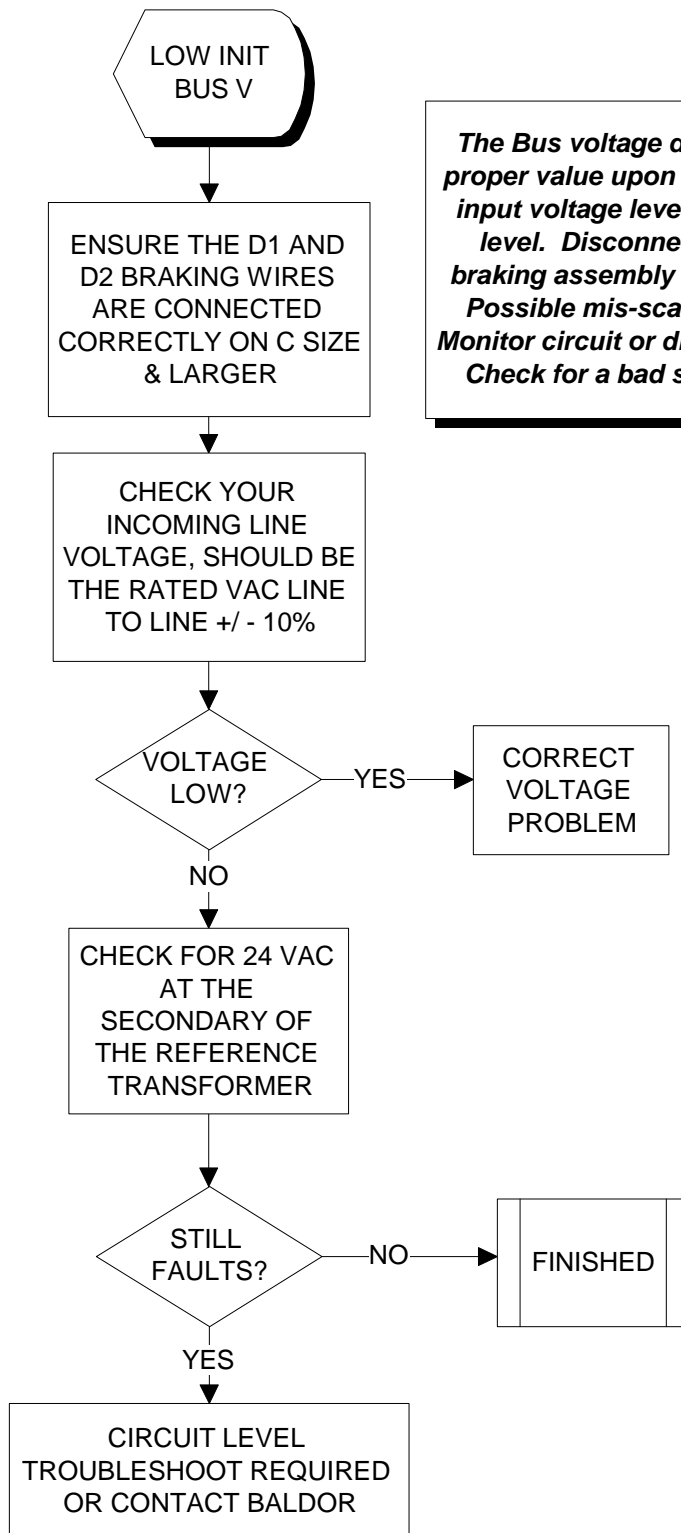
The Bus voltage did not rise to it's proper value upon power up. Check input voltage level and the DC bus level. Disconnect the dynamic braking assembly wiring and retry. Possible mis-scaled Bus Voltage Monitor circuit or disconnected cable. Check for a bad soft start circuit.

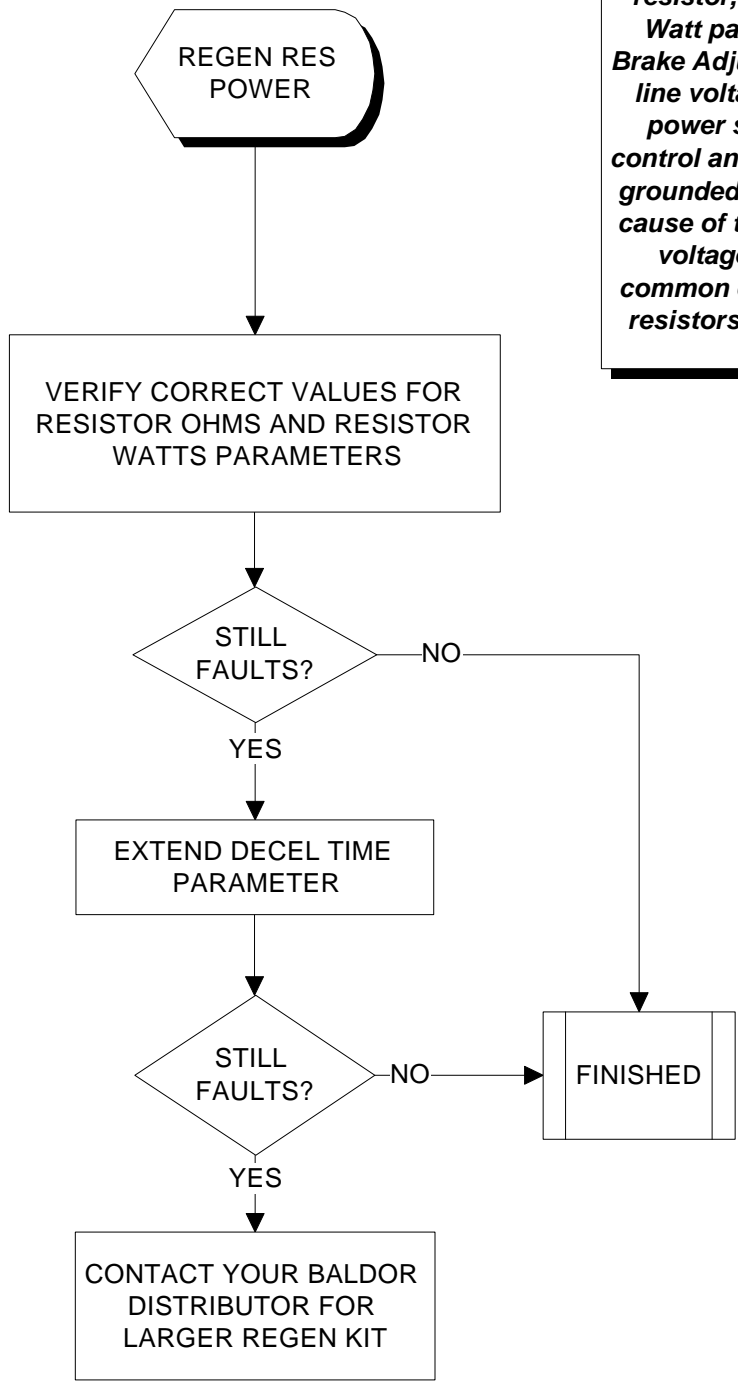
The regeneration power has exceeded the programmed power rating of the braking resistor, set by the resistor Watt parameters, Level 2, Brake Adjust Block. Check the line voltage and for a Delta power supply. Verify the control and motor are properly grounded. The most common cause of this fault is high line voltage. The next most common cause is undersized resistors for the application.
