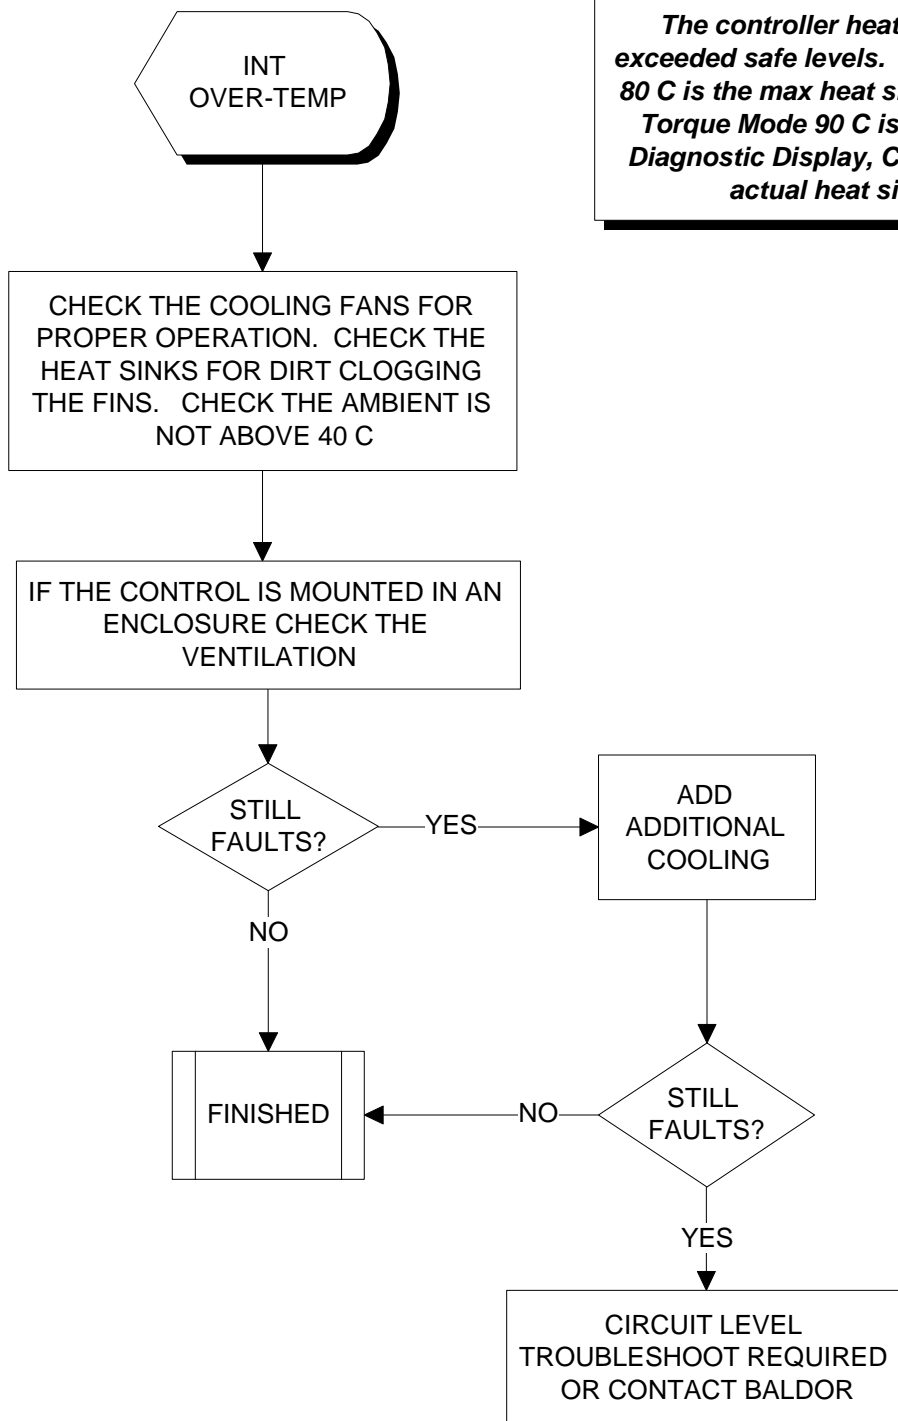
The controller heat sink temperature has exceeded safe levels. In Constant Torque Mode 80 C is the max heat sink temp., and in Variable Torque Mode 90 C is the maximum. Use the Diagnostic Display, CONTROL TMP to see the actual heat sink temperature.

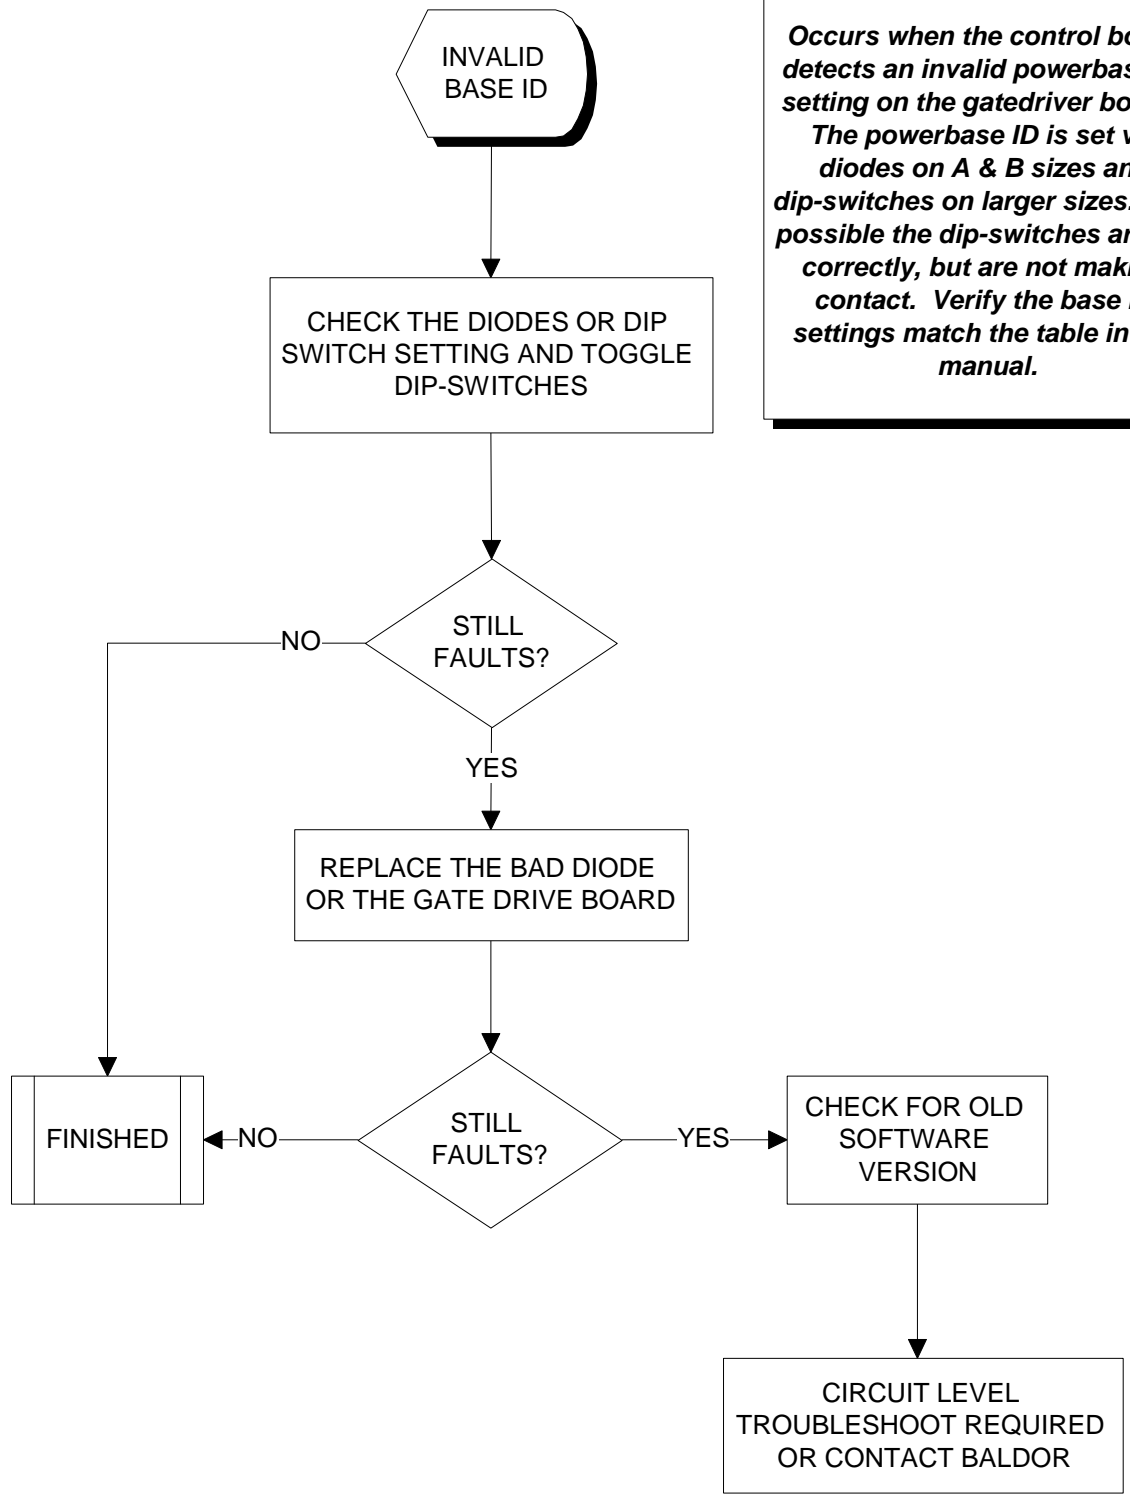
Occurs when the control board detects an invalid powerbase ID setting on the gatedriver board. The powerbase ID is set via diodes on A & B sizes and dip-switches on larger sizes. It is possible the dip-switches are set correctly, but are not making contact. Verify the base ID settings match the table in the manual.

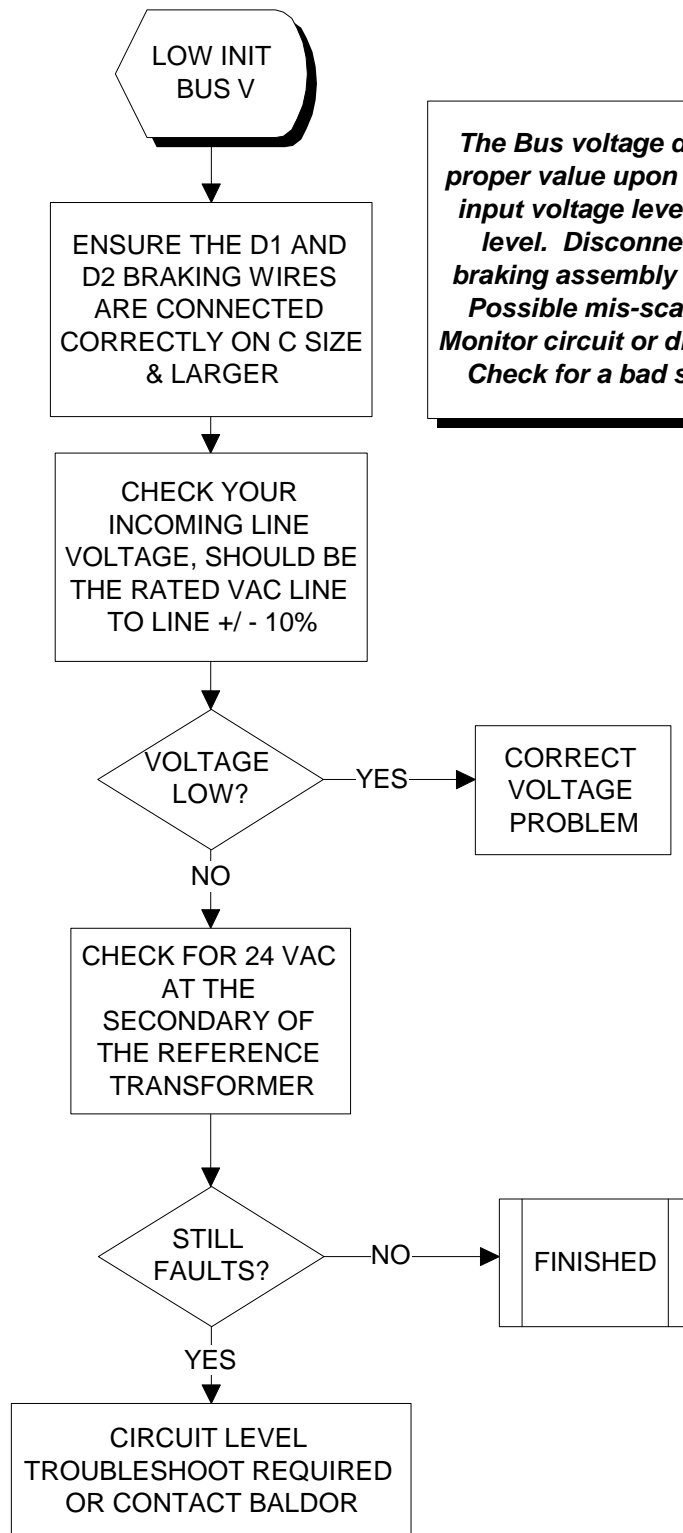
The Bus voltage did not rise to it's proper value upon power up. Check input voltage level and the DC bus level. Disconnect the dynamic braking assembly wiring and retry. Possible mis-scaled Bus Voltage Monitor circuit or disconnected cable. Check for a bad soft start circuit.

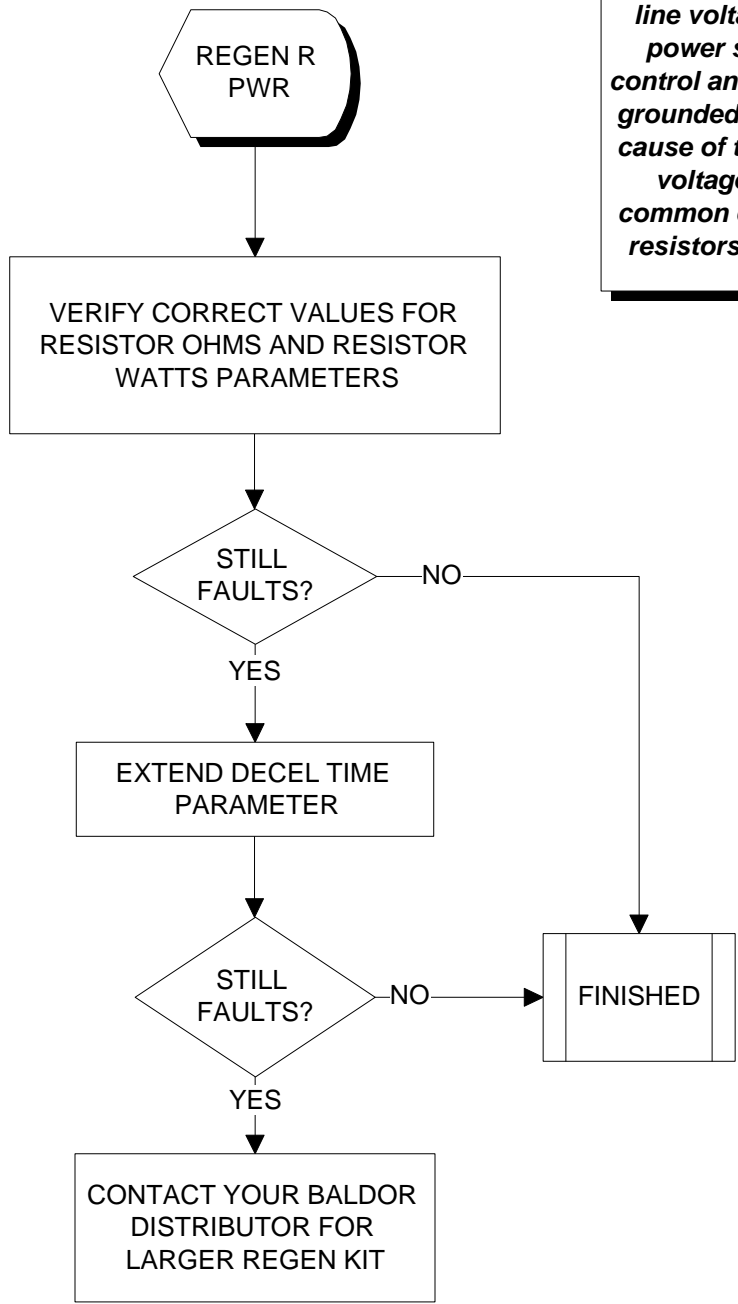
The regeneration power has exceeded the programmed power rating of the braking resistor, set by the resistor Watt parameters, Level 2, Brake Adjust Block. Check the line voltage and for a Delta power supply. Verify the control and motor are properly grounded. The most common cause of this fault is high line voltage. The next most common cause is undersized resistors for the application.
