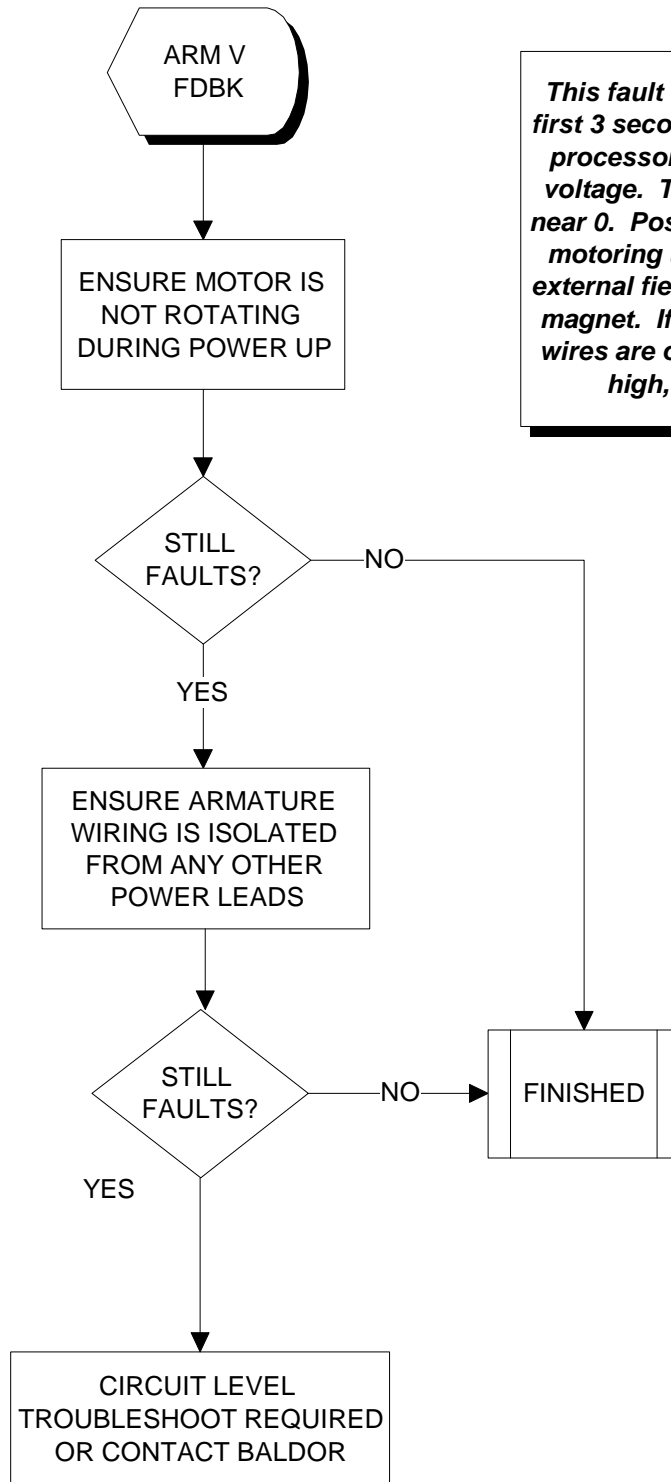
This fault can only happen in the first 3 seconds after power up. The processor looks at the armature voltage. The voltage needs to be near 0. Possible cause is a rotating motoring upon power up with an external field supply, or permanent magnet. If the armature wires are off, the feedback will be high, causing this fault.

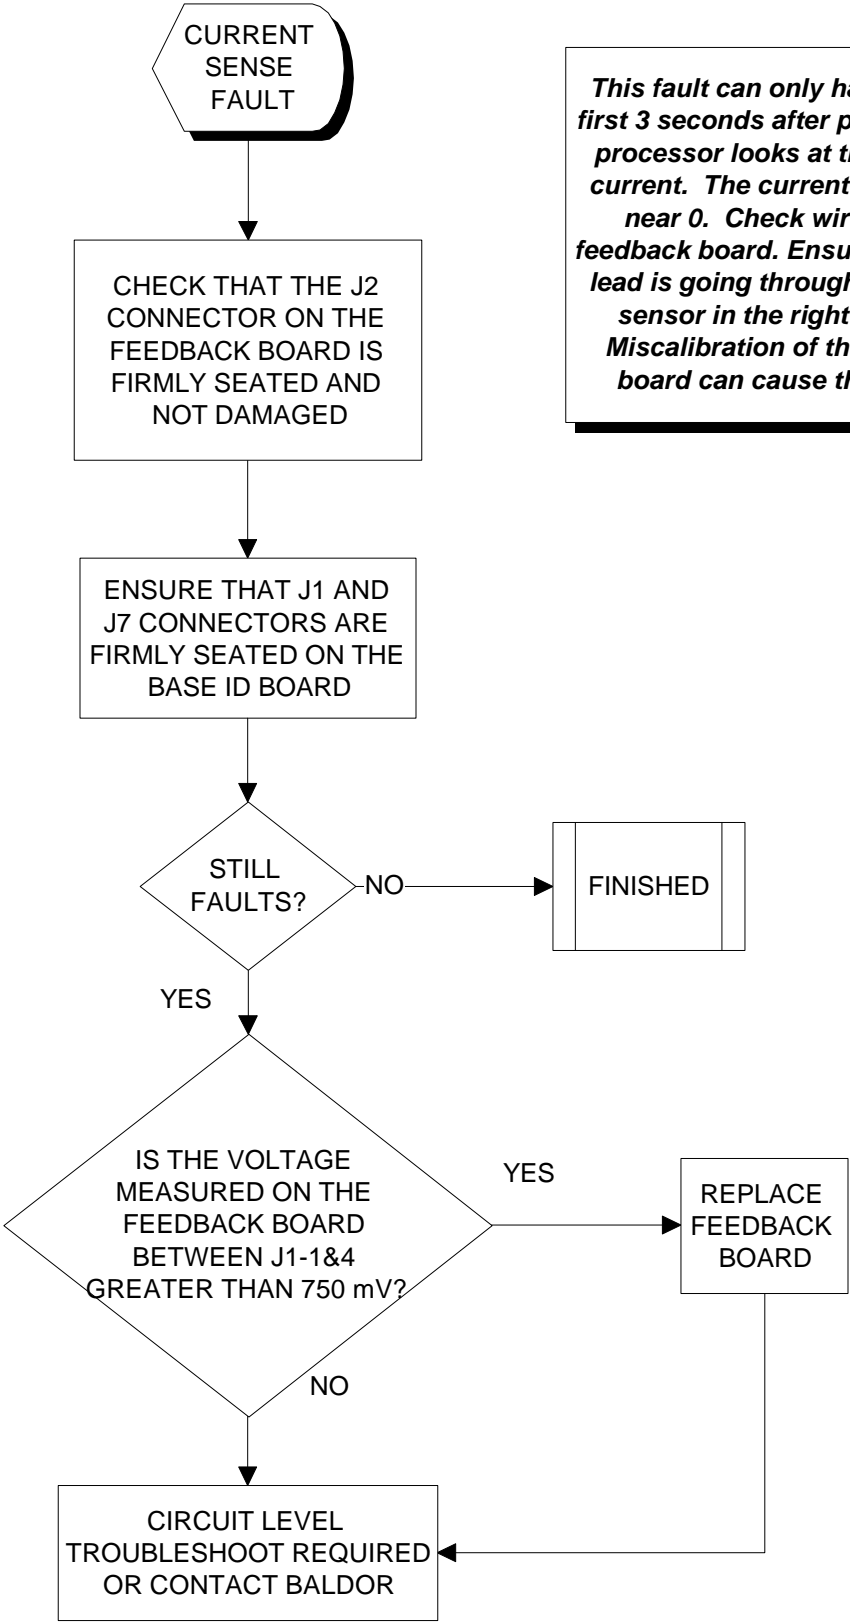
CURRENT
SENSE
FAULT

CHECK THAT THE J2
CONNECTOR ON THE
FEEDBACK BOARD IS
FIRMLY SEATED AND
NOT DAMAGED

ENSURE THAT J1 AND
J7 CONNECTORS ARE
FIRMLY SEATED ON THE
BASE ID BOARD

IS THE VOLTAGE
MEASURED ON THE
FEEDBACK BOARD
BETWEEN J1-1&4
GREATER THAN 750 mV?

REPLACE
FEEDBACK
BOARD

This fault can only happen in the first 3 seconds after power up. The processor looks at the armature current. The current needs to be near 0. Check wiring to the feedback board. Ensure that the A2 lead is going through the current sensor in the right direction. Miscalibration of the feedback board can cause this as well.

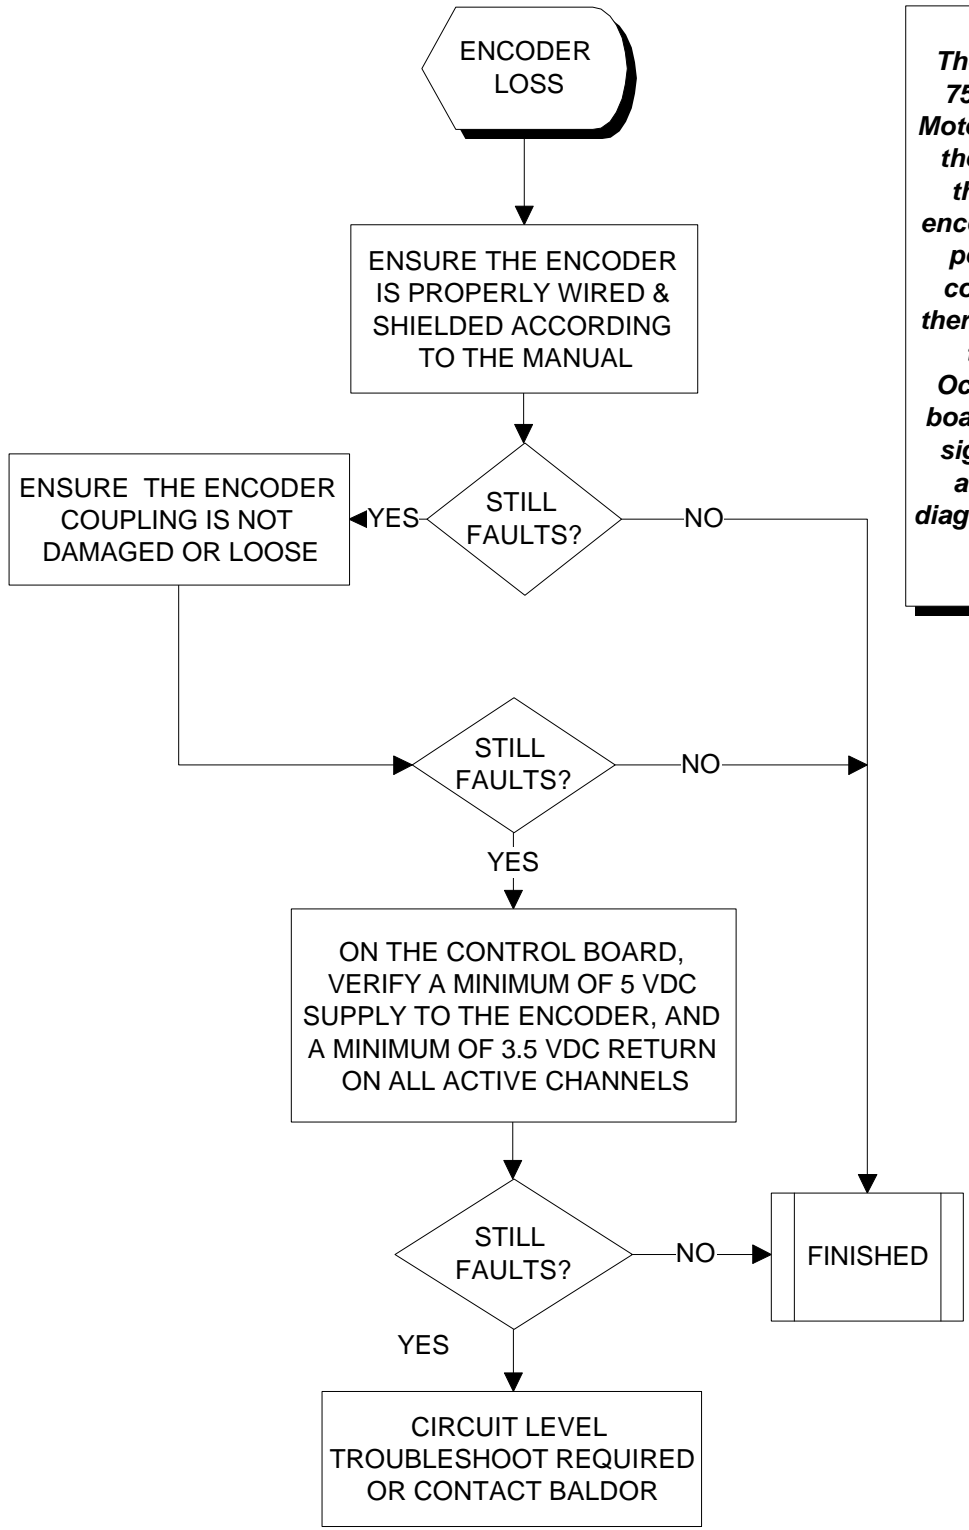
The Armature Voltage is 75% or greater than the Motor Rated Arm Volts, and the processor sees less than 8% of speed. The encoder has experienced a power supply loss, the coupling has slipped or there is excessive noise on the encoder signals. Occurs when the control board detects the encoder signal is running then is abruptly lost. Use the diagnostic screen to find the problem.

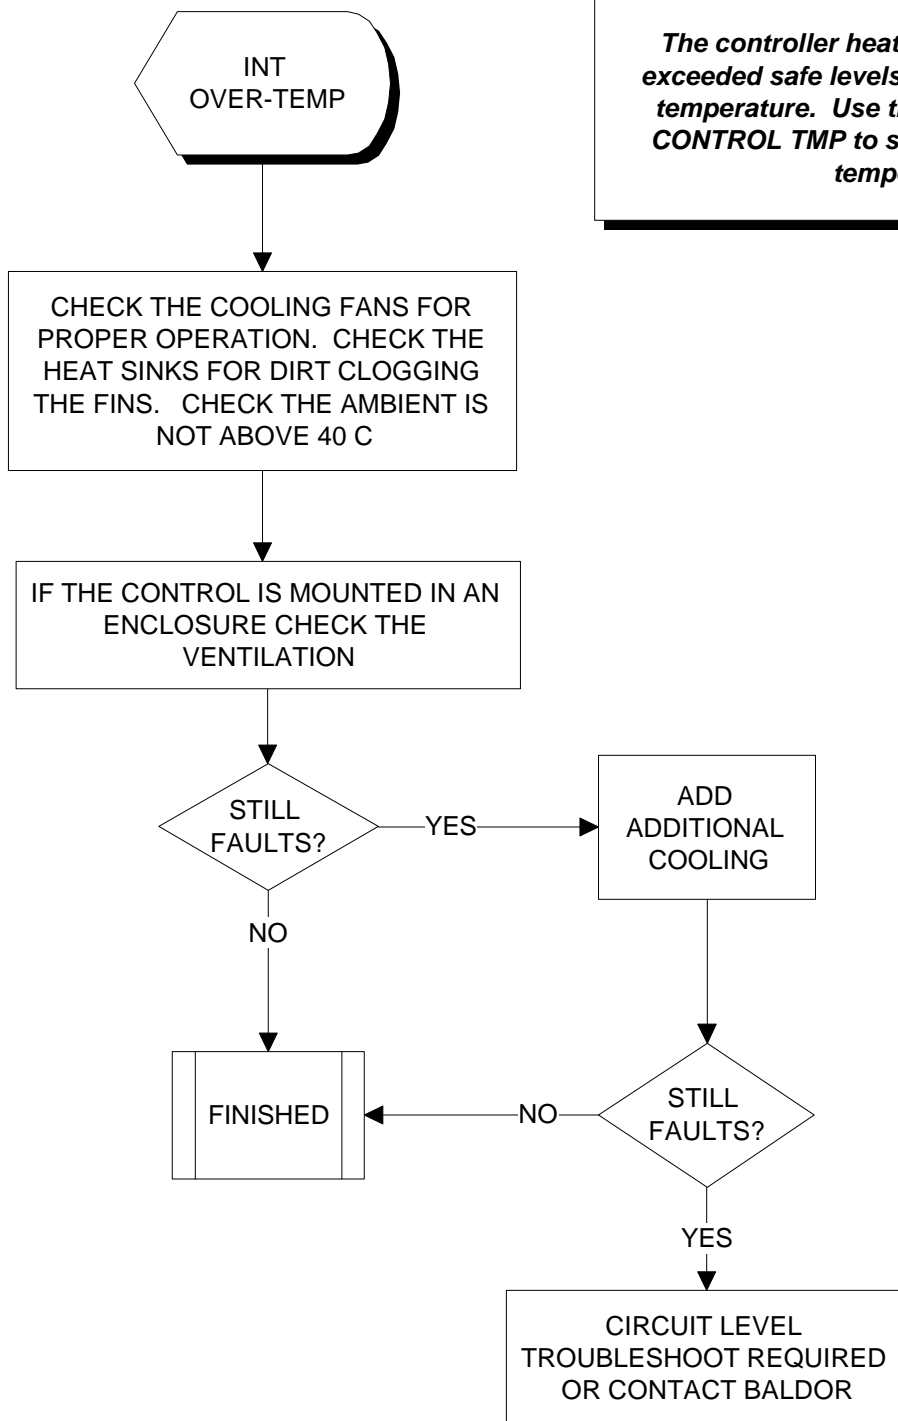
The controller heat sink temperature has exceeded safe levels. 90 C is the maximum temperature. Use the Diagnostic Display, CONTROL TMP to see the actual heat sink temperature.

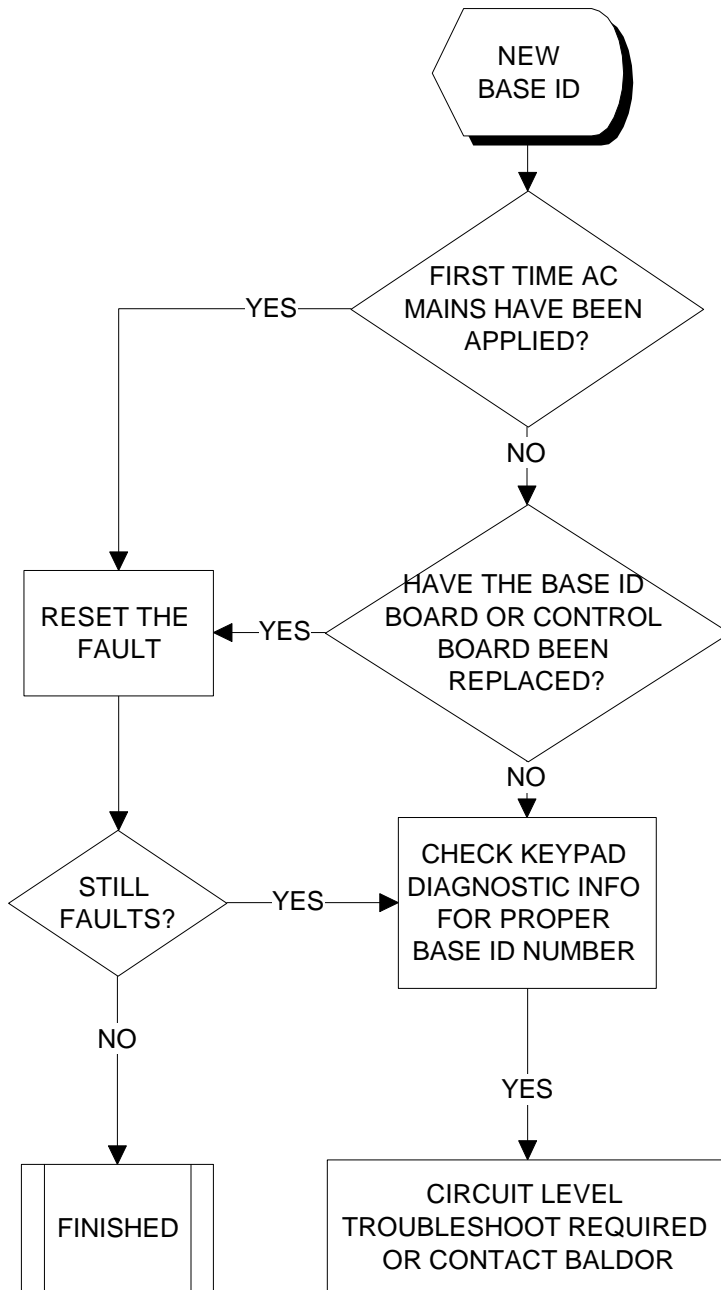
This fault occurs when a controller is powered up for the first time or when a new control board is installed on a controller. This fault will appear EVEN WHEN THE POWERBASE ID IS CORRECTLY SET ON THE BASE ID BOARD. The fault occurs because the base ID stored is different than what the control found on power up. This fault is cleared by pushing the reset button.

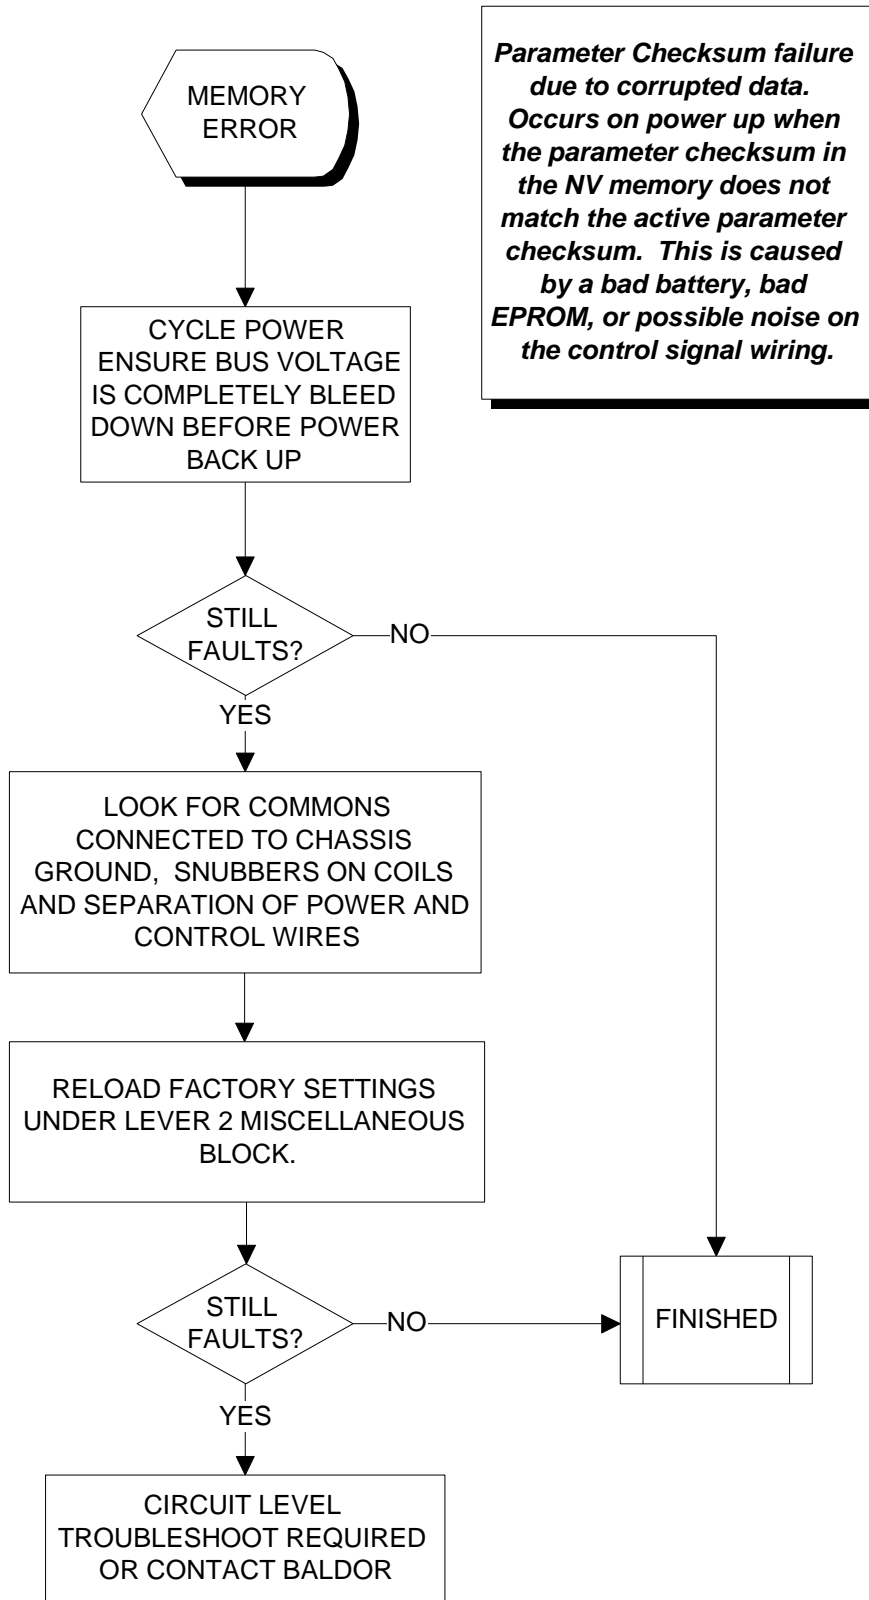
MEMORY
ERROR

Parameter Checksum failure due to corrupted data. Occurs on power up when the parameter checksum in the NV memory does not match the active parameter checksum. This is caused by a bad battery, bad EPROM, or possible noise on the control signal wiring.

CYCLE POWER
ENSURE BUS VOLTAGE
IS COMPLETELY BLEED
DOWN BEFORE POWER
BACK UP

LOOK FOR COMMONS
CONNECTED TO CHASSIS
GROUND, SNUBBERS ON COILS
AND SEPARATION OF POWER AND
CONTROL WIRES

RELOAD FACTORY SETTINGS
UNDER LEVER 2 MISCELLANEOUS
BLOCK.

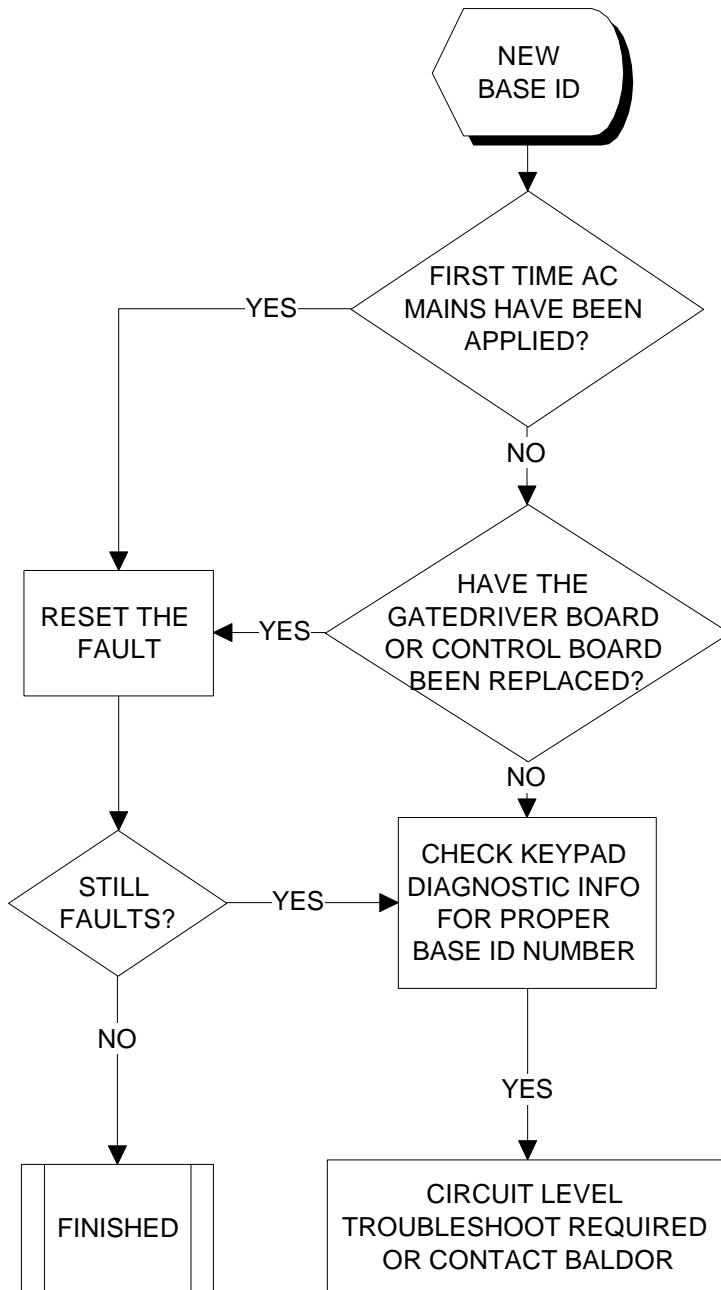
This fault occurs when a controller is powered up for the first time or when a new control board is installed on a controller. This fault will appear EVEN WHEN THE POWERBASE ID IS CORRECTLY SET ON THE GATEDRIVER BOARD. The fault occurs because the base ID stored is different than what the control found on power up. This fault is cleared by pushing the reset button.

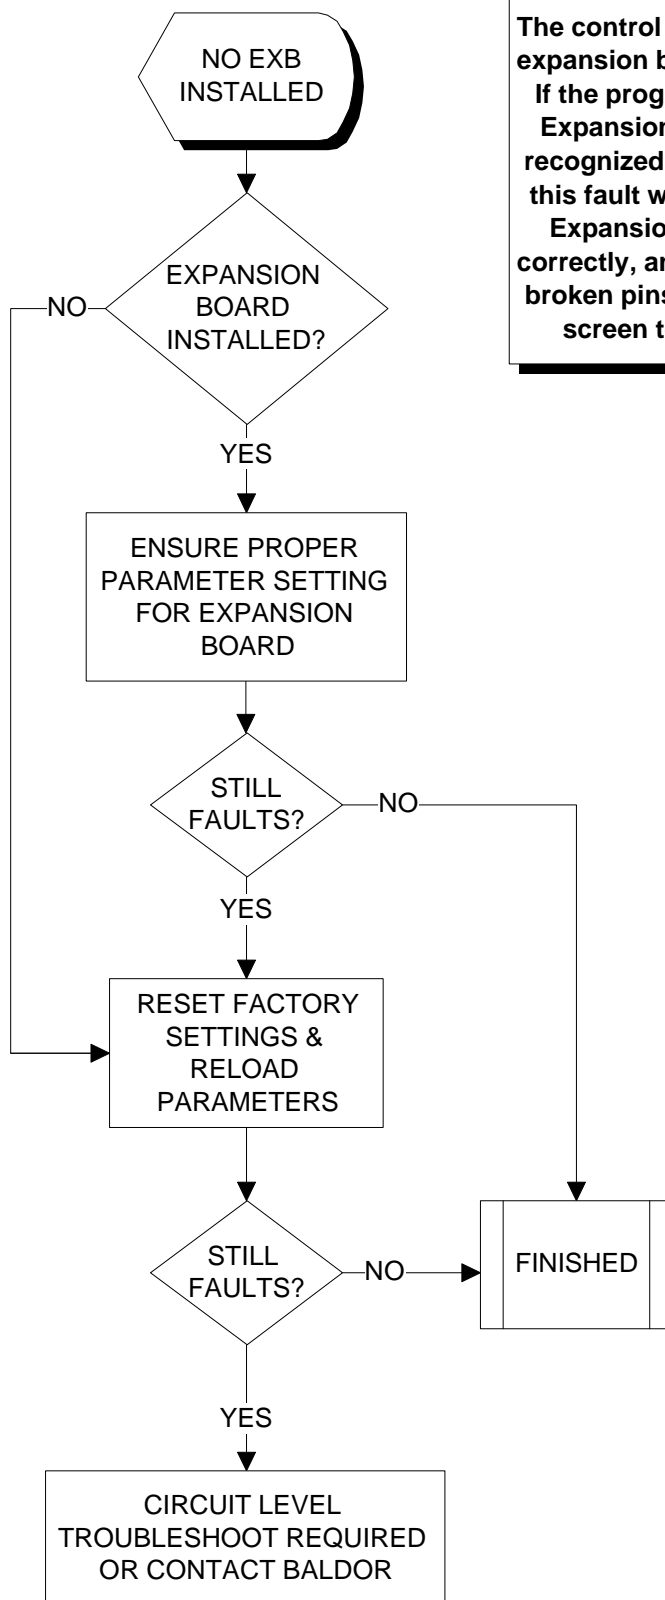
The control board recognizes any expansion board that is installed. If the programming calls for an Expansion board, and it is not recognized by the control board, this fault will occur. Ensure the Expansion board is installed correctly, and there are no bent or broken pins. Use the diagnostic screen to find the problem.

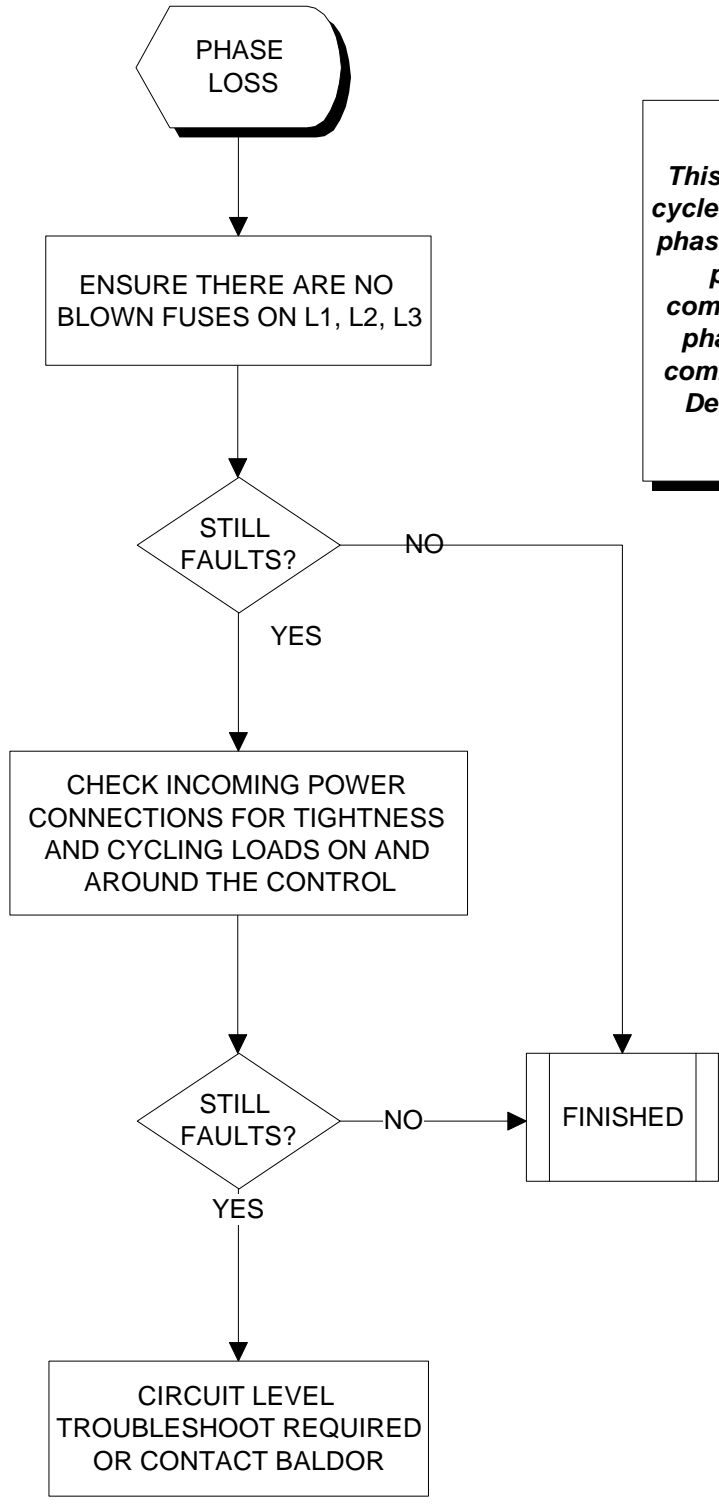
This fault occurs after 5 cycles of a phase loss or a phase that is no longer in proper sequence compared to the other 2 phases. This is more common on Unbalanced Delta power supplies.

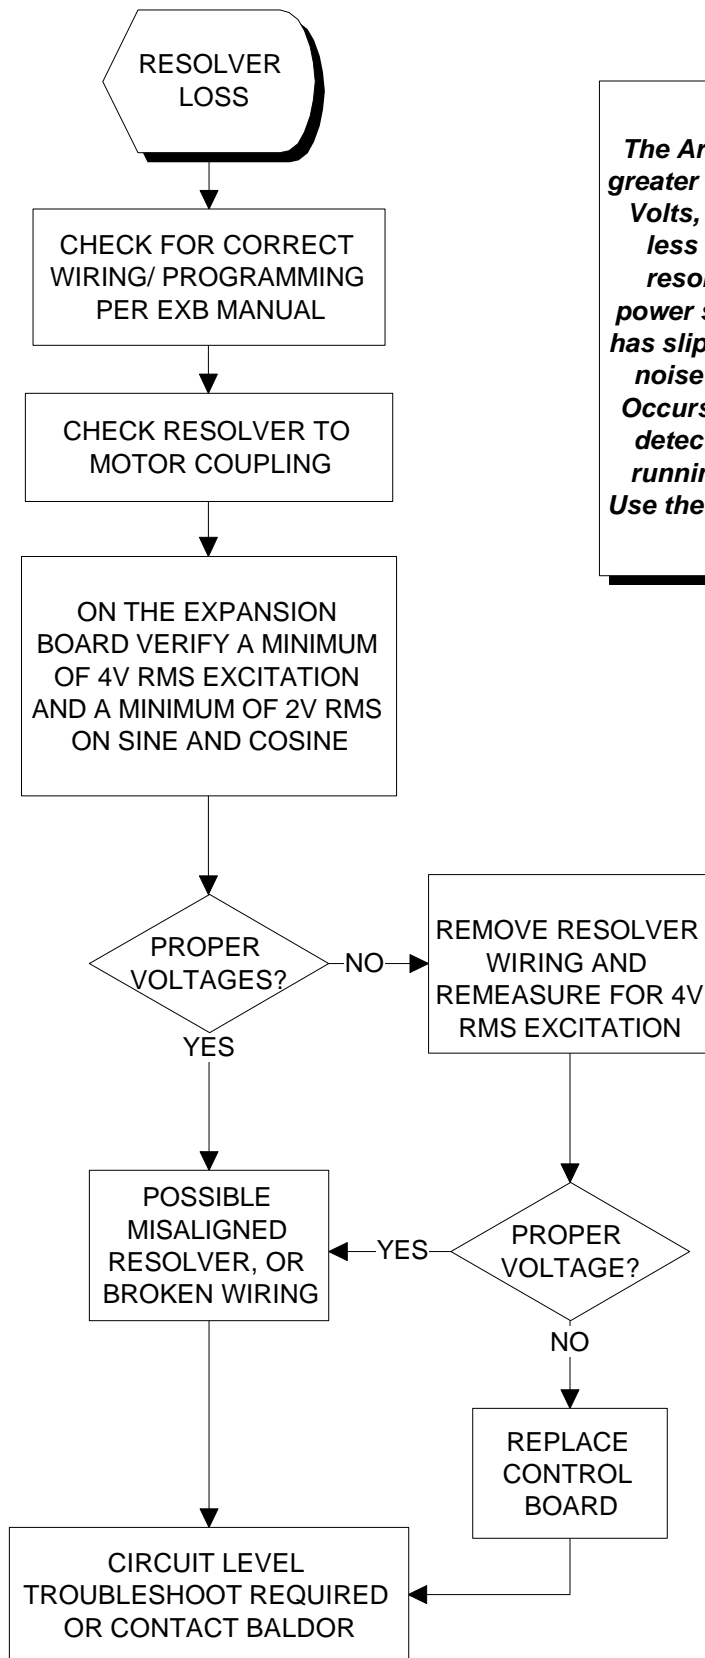
The Armature Voltage is 75% or greater than the Motor Rated Arm Volts, and the processor sees less than 8% of speed. The resolver has experienced a power supply loss, the coupling has slipped or there is excessive noise on the resolver signals. Occurs when the control board detects the resolver signal is running then is abruptly lost. Use the diagnostic screen to find the problem.

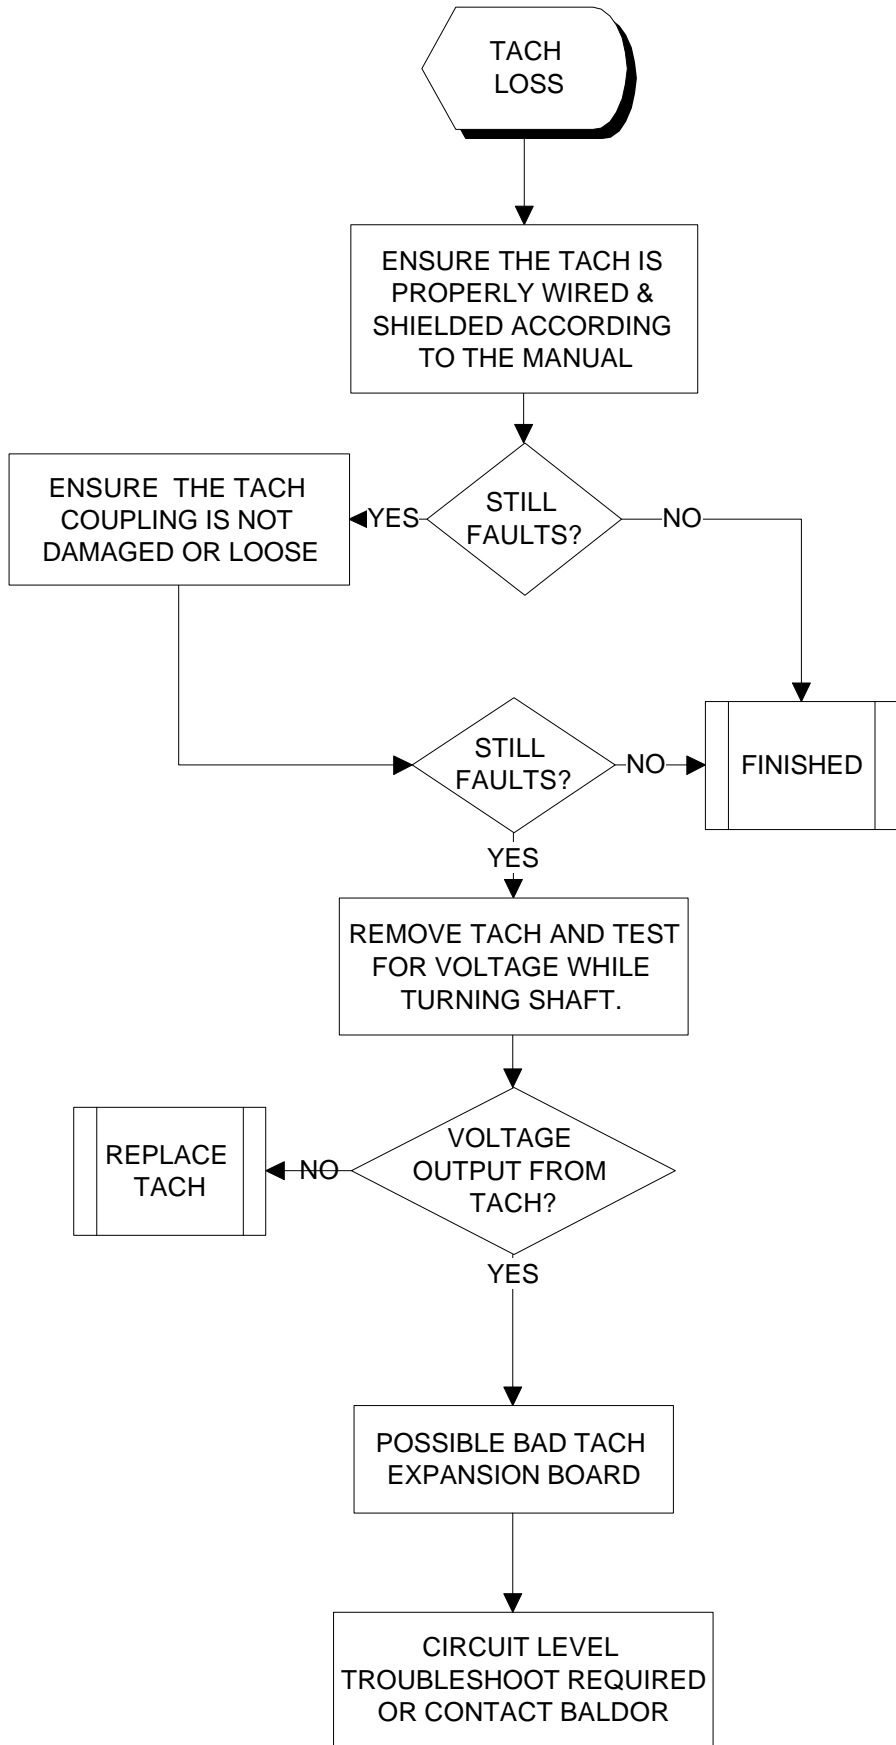
The Armature Voltage is 75% or greater than the Motor Rated Arm Volts, and the processor sees less than 8% of speed. The tach has experienced a power supply loss, the coupling has slipped or there is excessive noise on the tach signals. Occurs when the control board detects the tach signal is running then is abruptly lost. Use the diagnostic screen to find the problem.

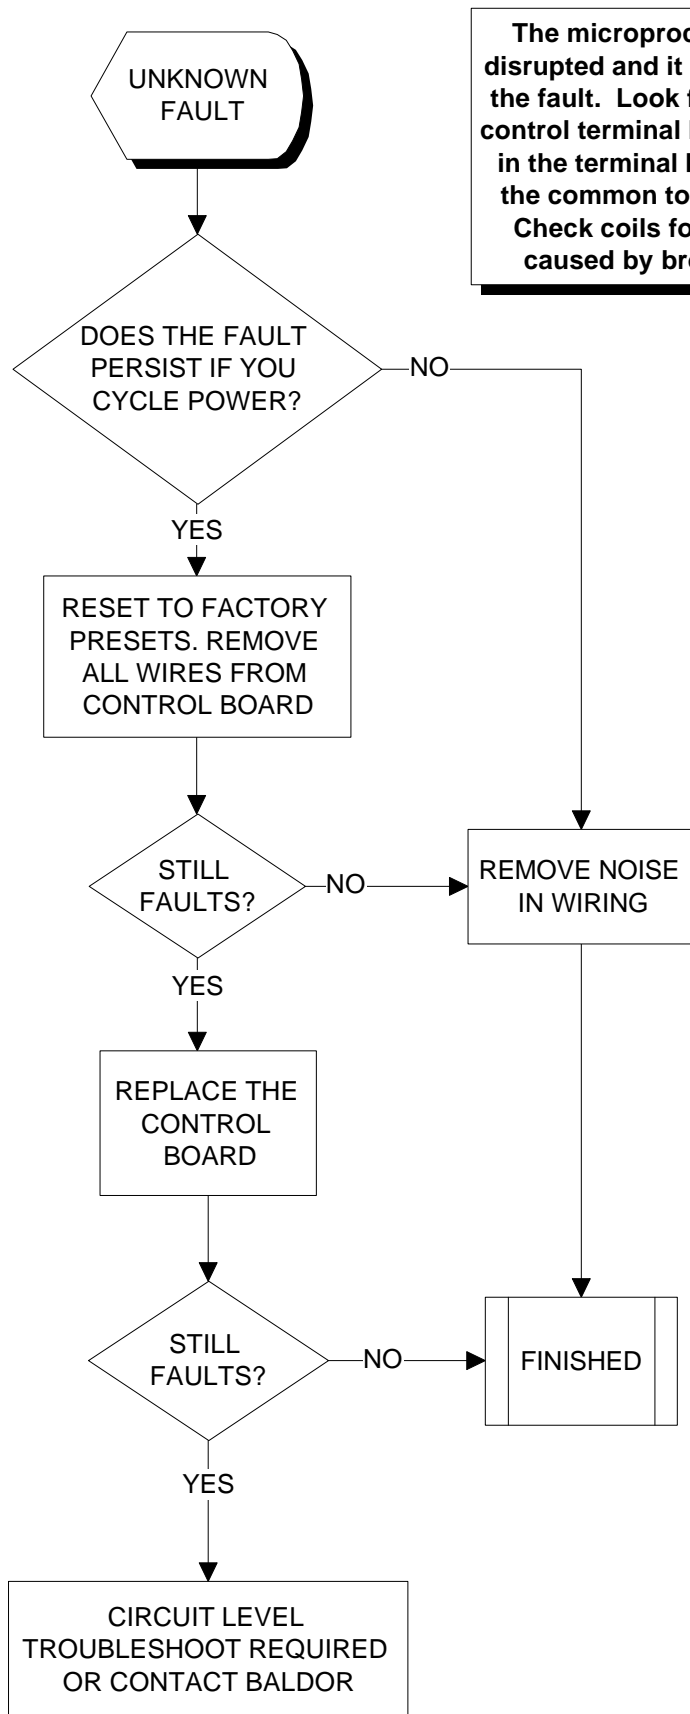
The microprocesspower has been disrupted and it is unable to determine the fault. Look for connections to the control terminal block that create noise in the terminal block or grounding of the common to the chassis ground. Check coils for snubbers. Can be caused by brown out conditions.
