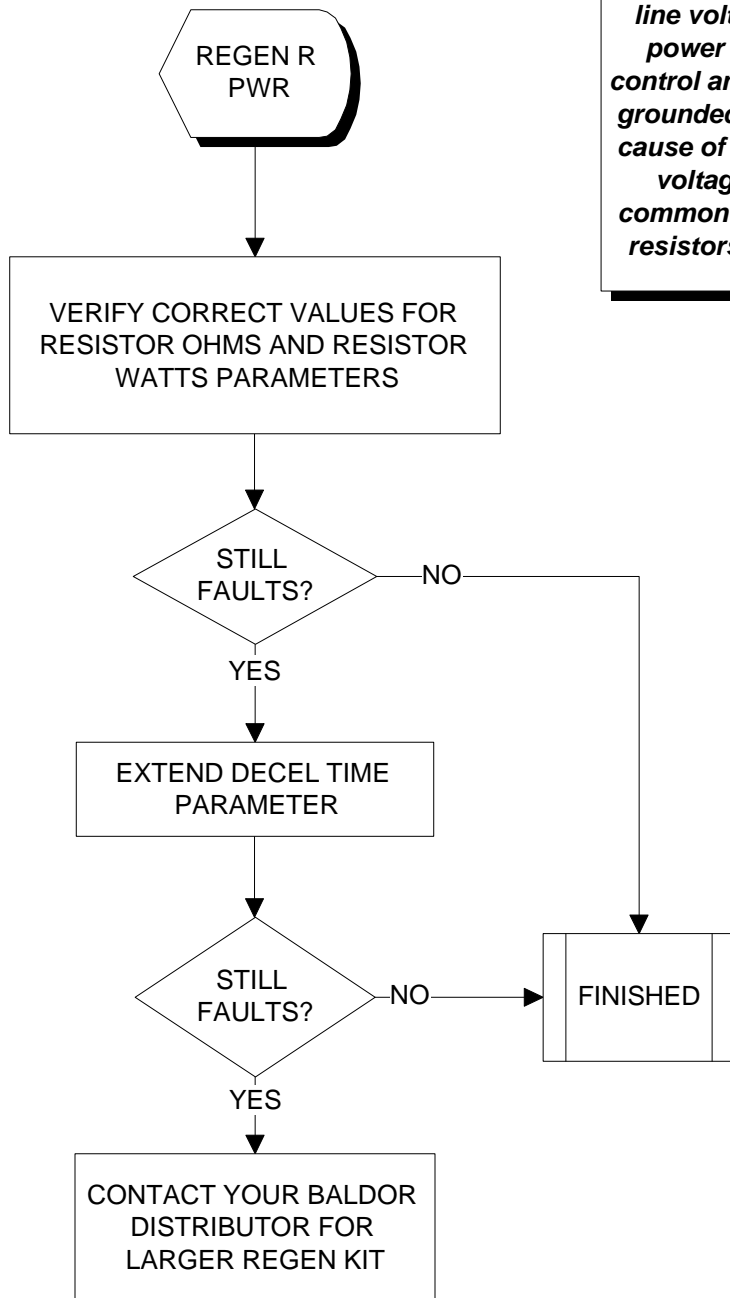
The regeneration power has exceeded the programmed power rating of the braking resistor, set by the resistor Watt parameters, Level 2, Brake Adjust Block. Check the line voltage and for a Delta power supply. Verify the control and motor are properly grounded. The most common cause of this fault is high line voltage. The next most common cause is undersized resistors for the application.
