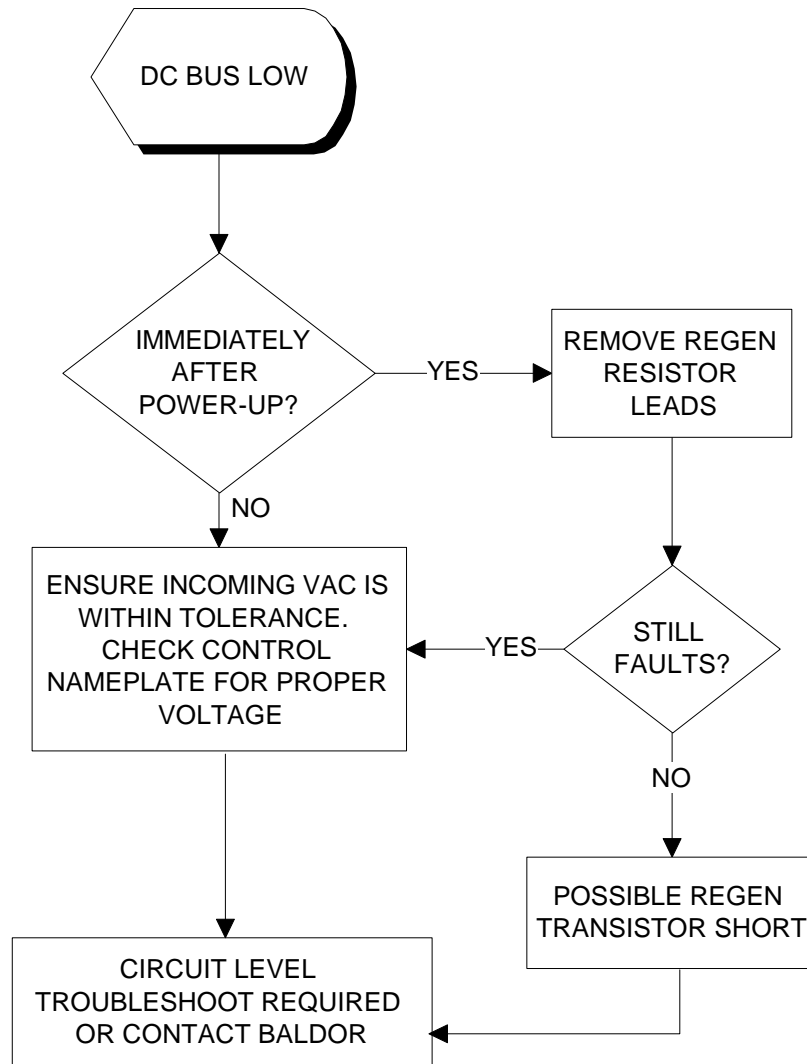
The DC Bus voltage has dropped below 400/200/100 VDC (460/230/115 VAC input). If this is a new installation with an external Regen Kit check the wiring on B+ and B-. The most common reasons for this fault are Regen Transistor failure, Soft Start circuit failure or a failed diode bridge. If it occurs during running, the likely failure is the soft start contactor is not closed.

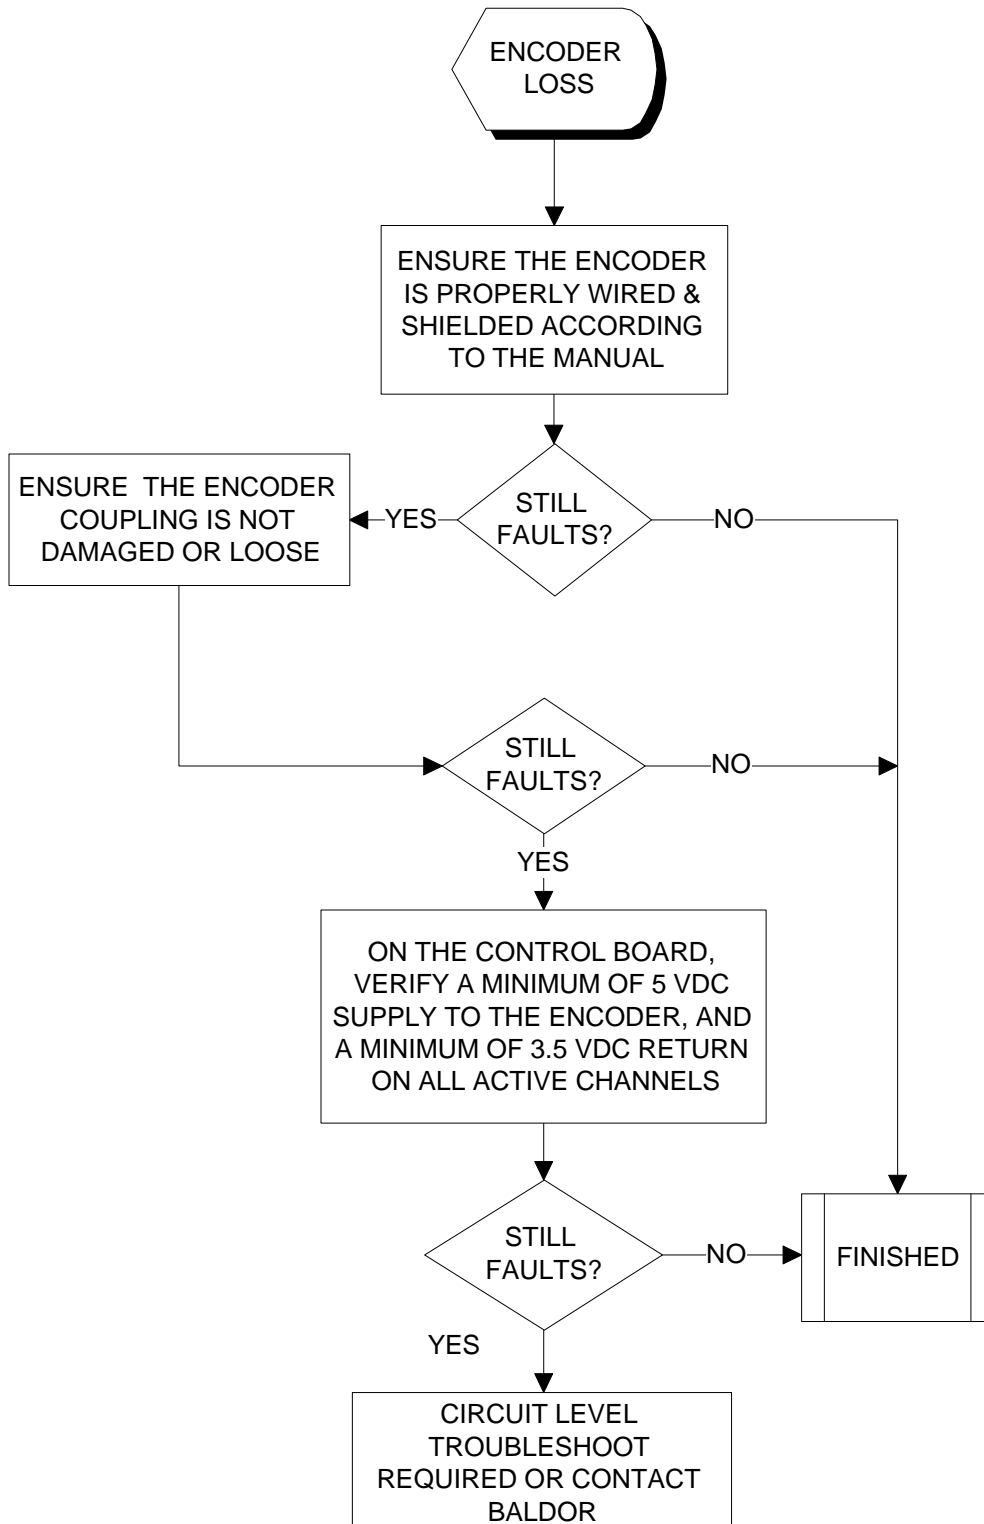
The encoder has experienced a power supply loss, the coupling has slipped or there is excessive noise on the encoder signals. Occurs when the control board detects the encoder signal is running then is abruptly lost. Use the diagnostic screen to find the problem.

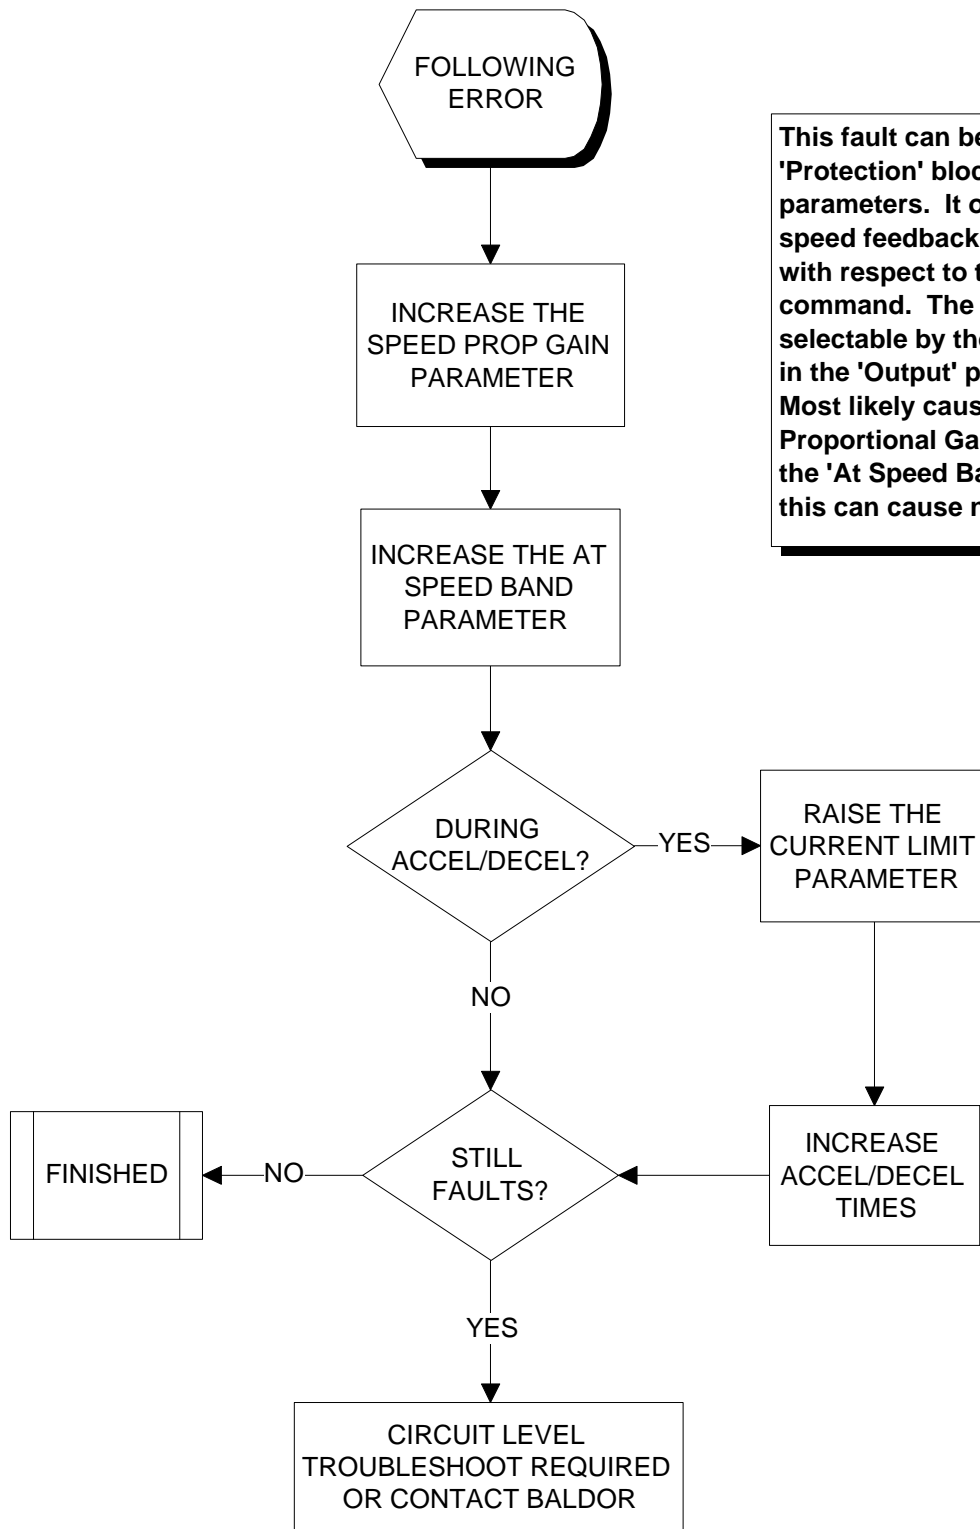
This fault can be turned off in the 'Protection' block of the parameters. It occurs when the speed feedback is out of tolerance with respect to the speed command. The tolerance level is selectable by the 'At Speed Band' in the 'Output' parameter block. Most likely cause is the 'Speed Proportional Gain' being too low. If the 'At Speed Band' is set too low, this can cause nuisance faults.

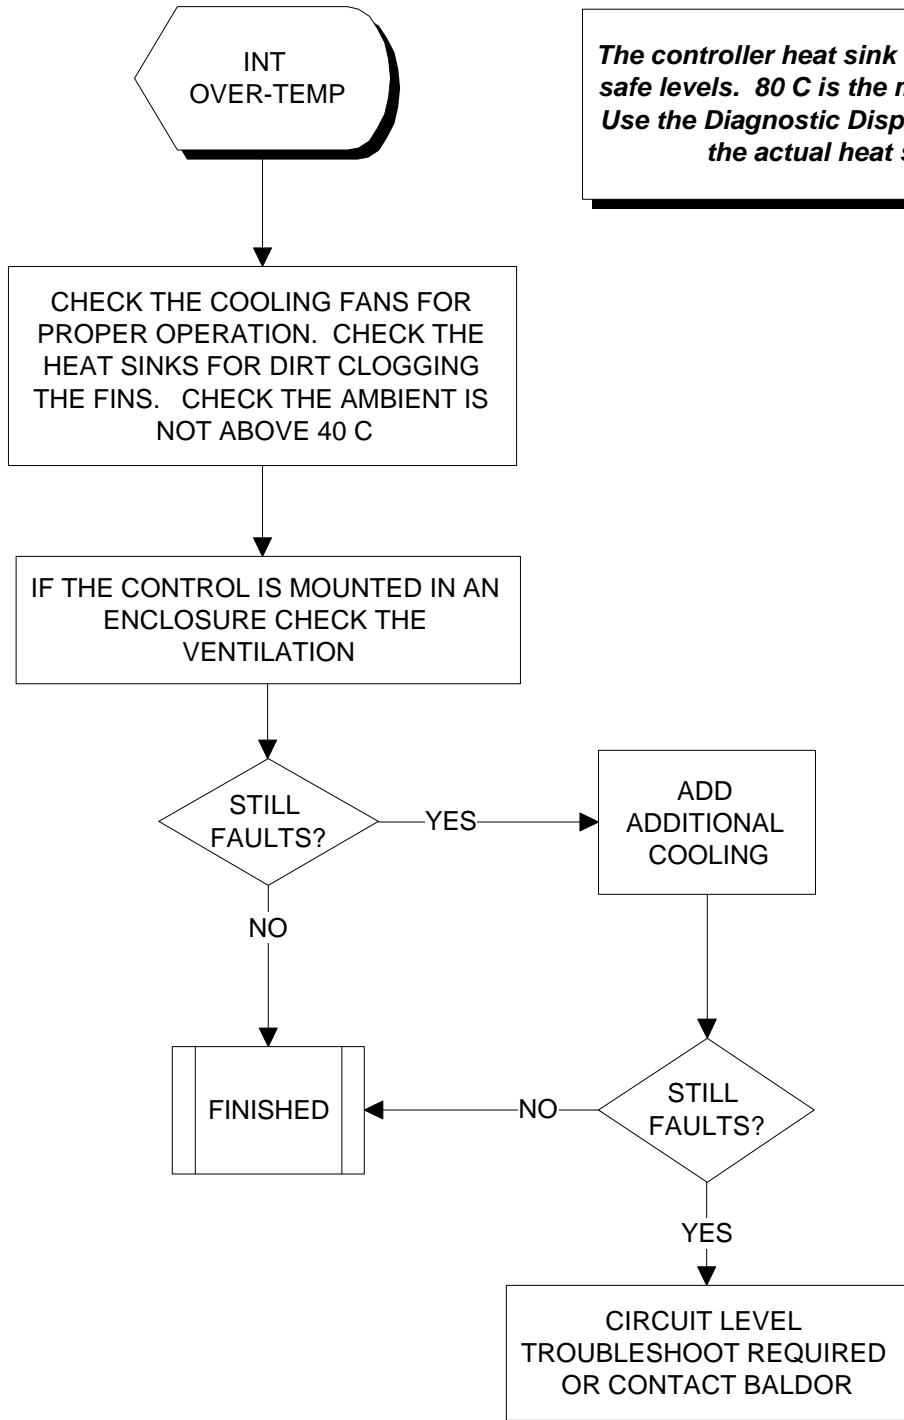
The controller heat sink temperature has exceeded safe levels. 80 C is the max heat sink temperature. Use the Diagnostic Display, CONTROL TMP to see the actual heat sink temperature.

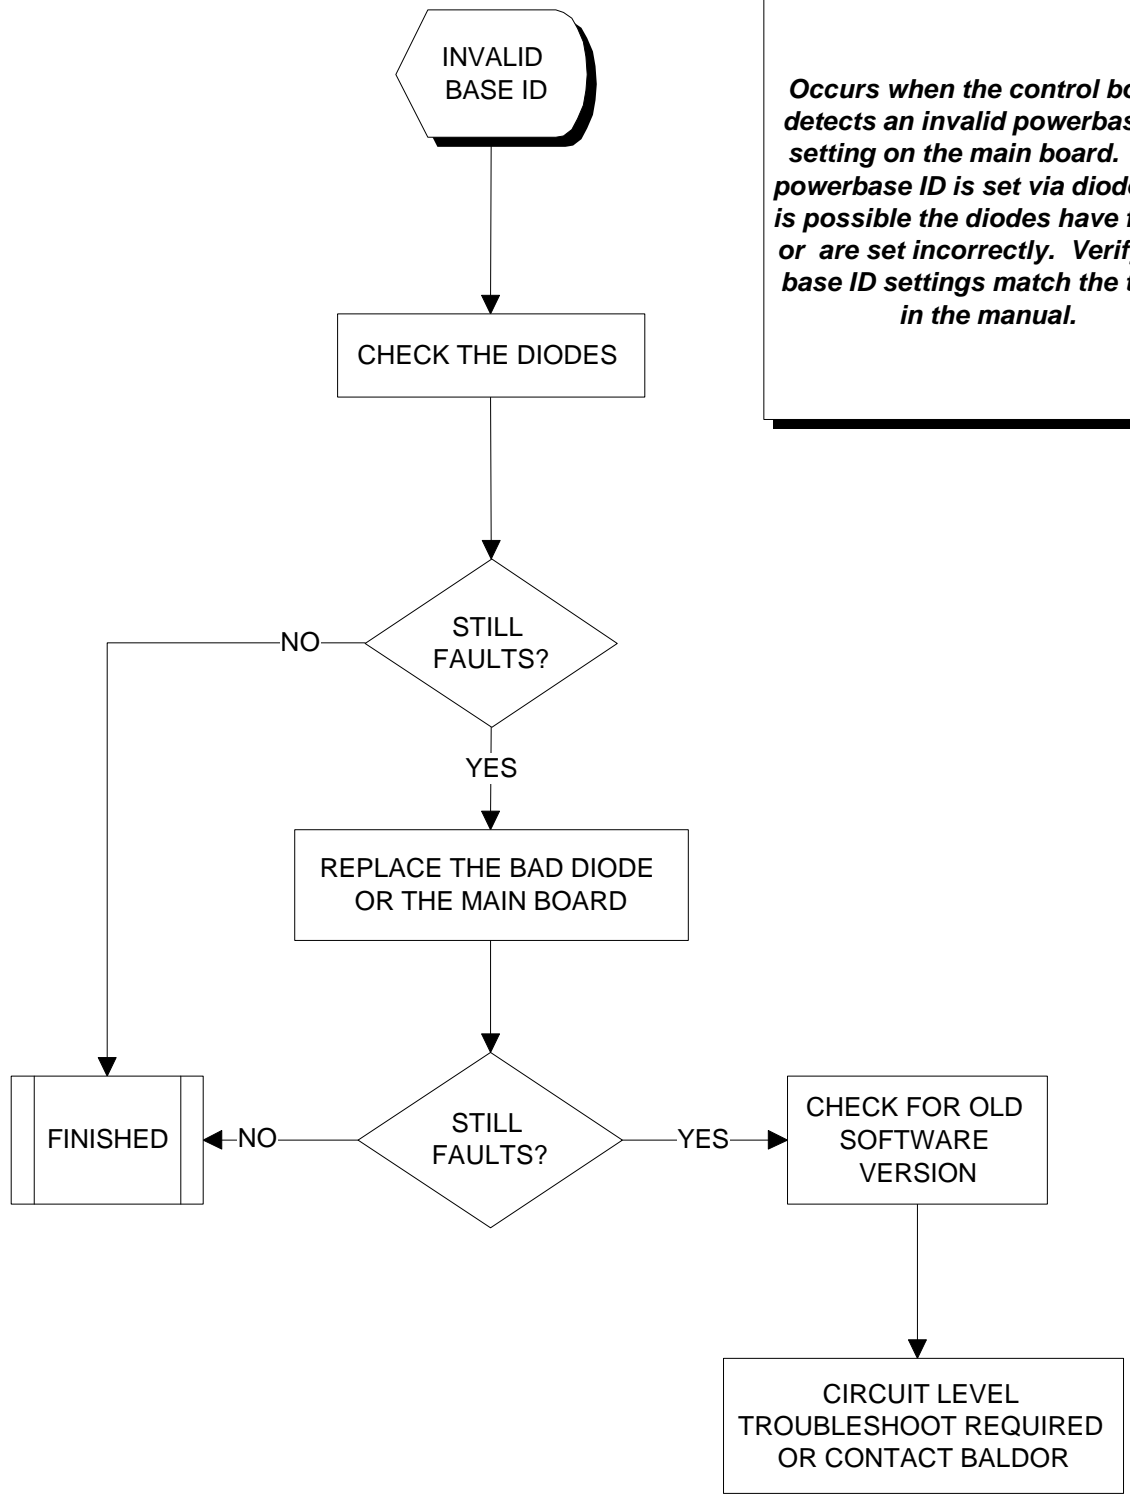
Occurs when the control board detects an invalid powerbase ID setting on the main board. The powerbase ID is set via diodes. It is possible the diodes have failed or are set incorrectly. Verify the base ID settings match the table in the manual.

This is a hardware generated fault when the logic power supply drops below 21 VDC. On -PO controls this fault also happens when the external Power Supply has a fault. Check the X10 connector.

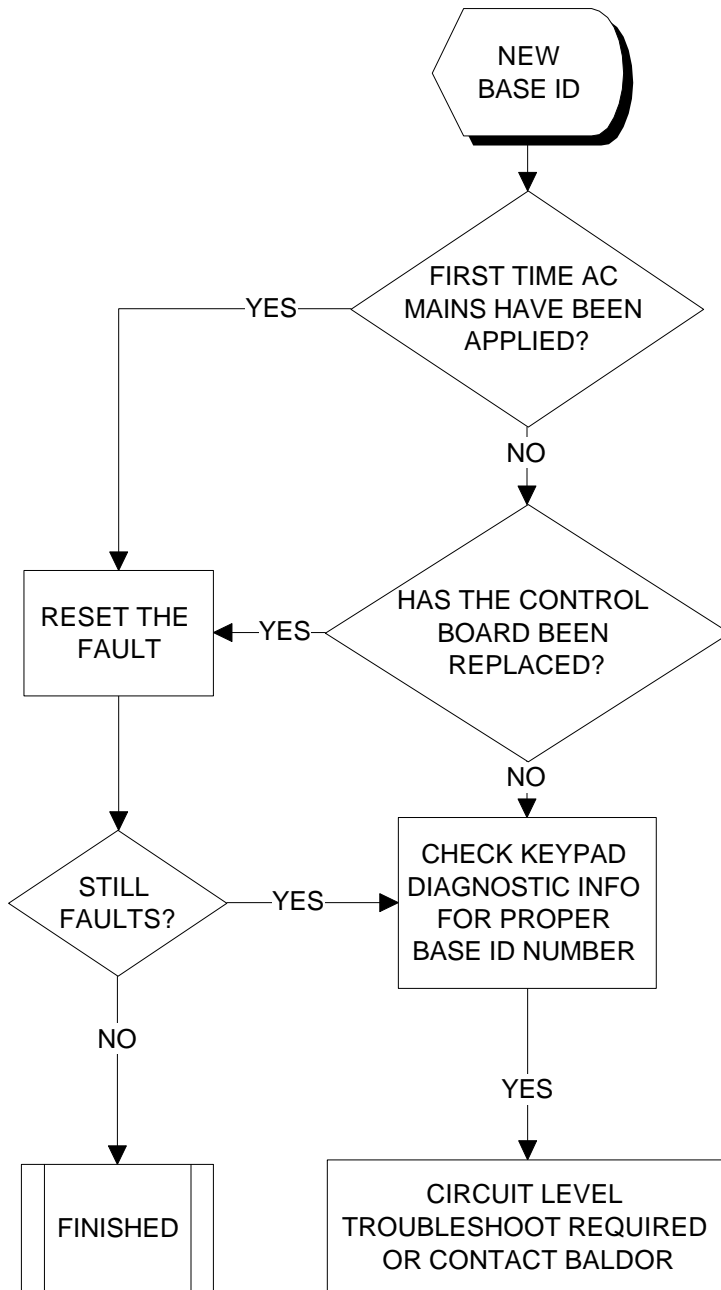
This fault occurs when a controller is powered up for the first time or when a new control board is installed on a controller. This fault will appear EVEN WHEN THE POWERBASE ID IS CORRECTLY SET ON THE MAIN BOARD. The fault occurs because the base ID stored is different than what the control found on power up. This fault is cleared by pushing the reset button.
